Static Liquefaction Causes the Flow Failure of a Tailings Dam: A Case Study of El Descargador, Cartagena–La Unión Mining Region, SE Spain (October 1963)

Abstract: The aim of this work is to investigate the causes of the El Descargador tailings dam failure, at the mine district Cartagena–La Unión (SE Spain), in October 1963. Dam stability back analyses have been carried out by applying a geotechnical and geophysical approach. The failure occurred in the form of several landslides in five different points along the dam structure. The rise in the pore pressure and the steeped slopes of the tails, scaling up to 40° in some sectors, were the main causal preparatory factors. Here we propose that static liquefaction is the most plausible cause of the tailings dam flow failure. The presence of sand dikes and sand volcanoes with atypical stratigraphic architecture, both in the lagoon and at the surfaces exposed in the landslide areas, as well as the evidence of conspicuous sand fraction on the surface support the occurrence of the liquefaction processes. Major landslides were located near the drainage pipe and the flow directions were controlled by its position. Our results reveal that the

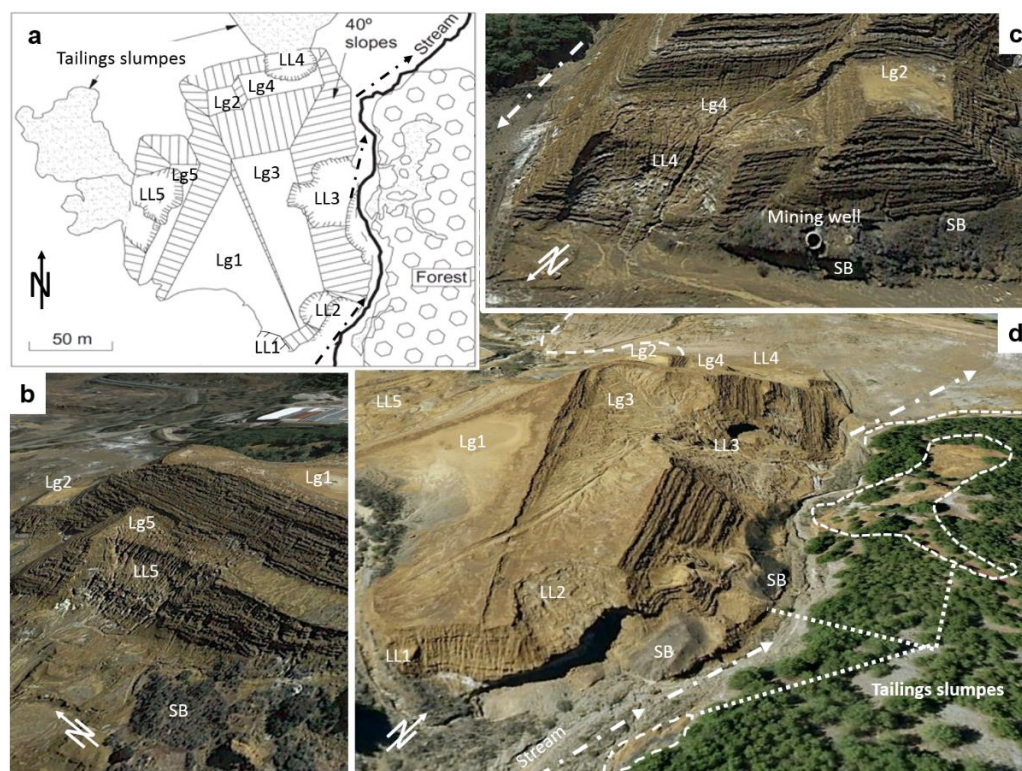
The tailings dam construction began in November 1953 and it was 42 m height at the time of the failure. The flow failure developed in five different landslide points (labeled LL; Figure 2). The height of the main landslide (LL3, Figure 3) was 27 m. 66,000 m³ of tailings and high acidic waters were released into the environment affecting: (1) an area of 4 km²; (2) different infrastructures (Cartagena–Cabo de Palos highway, the Cartagena–Los Blancos railroad); (3) the watercourse of Beal wadis stream; and (4) the El Mar Menor lagoon, an area of great ecological and patrimonial value in the Mediterranean Sea. Catastrophic mine tailings dam failures are increasing globally [2–12]. However, while the study of its ecological and socioeconomic consequences has been widely addressed in the literature [11–17] studies, attempts to address the hydro-geomechanical factors that caused the failures are scarce [18–20]. There is still more uncertainty regarding historical failures of dams that happened many decades ago, as is the case of El Descargador. This is an important gap of knowledge, since more than 80 uncontrolled old dams have been inventoried in this mining region [20]. The study of the causes that triggered and controlled the failure and collapse of ancient tailings dams such as El Descargador can provide valuable information to be considered in the design and management of such installations and its associated hazards, which are instrumental for the success of any mining operation.

Figure 2. (a) Layout of El Descargador tailings dam depicting the localization of different landslides (LL), lagoons (Lg), and fragments of breakwater (SB) and some are affected for flow failure. The discontinuous arrow indicates the direction of the runoff, (b–d) Oblique aerial views of the dam from different perspectives; source Spanish National Geographic Institute-IGN and Google Earth©. Schemes follow the same formatting.

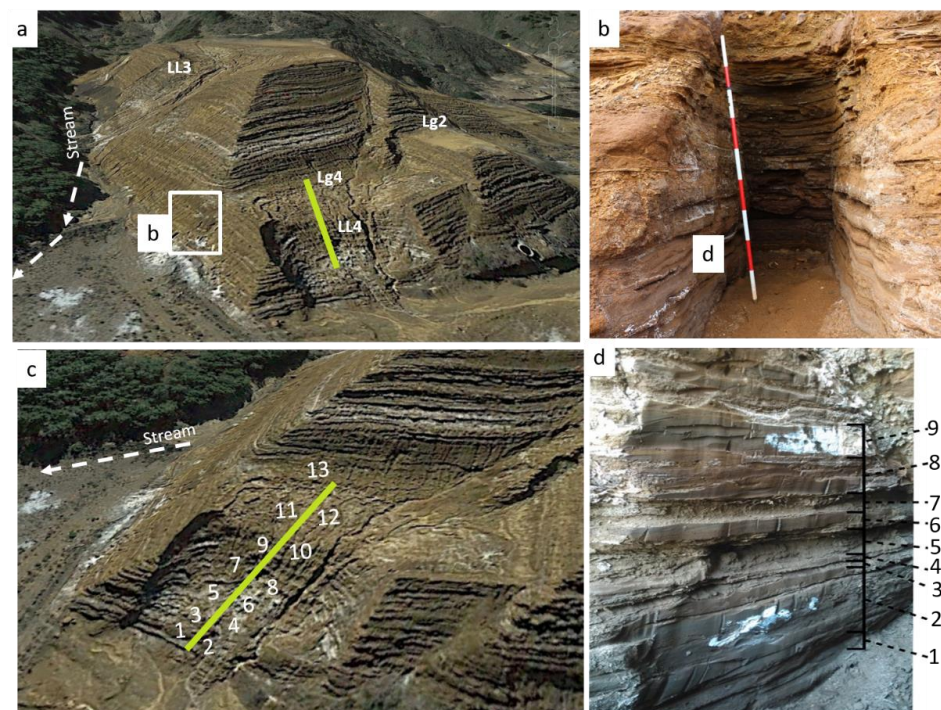
A sampling campaign was performed in May 2015 in two different zones: trial-pit profile and sampling of the sand dikes (Figure 4). The sampling aimed at comparing both unaltered and liquefacted materials. Up to nine representative tailings beds were sampled on the left side of a trial pit (1.7 m high and 1 m wide), which was dug in the northern sector of the East wall of the base of the tailings dam (Figure 2). Around 2 kg samples were collected, P1 being the lowest and P9 the shallowest sampling points. Once collected, they were preserved in sealed plastic bags to avoid quick oxidation. An additional 13 samples were extracted from several subvertical sand dikes crosscutting the fault plane in the north wall of the dam (Figure 4), W1 being the bottom and W13 being the top sample (Figure 4b).

Figure 4. (a) El Descargador tailings dam, (b) trial pit excavated in the East wall, (c) sampling points of sand dikes exposed on the surface of the landslide four (LL4), (d) detail sedimentary layer and sampling points by different layer in vertical profile. The white color indicates the precipitation of the different types of sulphates that contribute to the cementation of the tailings in the dam. The discontinuous arrow indicates the direction of the stream runoff.

The mine wastes are shown as low-resistivity materials ($\rho < 20 \Omega\text{m}$). The internal structure of the sedimentary layer of tailings could be observed on the walls of the test pit. The pit exposed an interbedded sequence of sands and a very fine-grained dark gray material (Figure 4a). The tailings layers thickness ranged from a few millimeters to several centimeters. Coarse- to medium-grained dark gray materials are coated by red-to-white hydrated sulphates, iron hydroxysulphates, and iron oxyhydroxides precipitation compounds. All sediments were completely or almost completely saturated in water regardless of their texture. It should be noted that the apparent cohesion of materials disappears when they become dry. The resistivity is even lower ($\rho < 5 \Omega\text{m}$) beneath the lagoons, up to at least 10 m-depth (Figure 6) and within the slid mass, at the foot of the northern sector of the tailings dam. These low-resistivity zones are interpreted as the geophysical signature of the materials saturated in saline waters related to acid mine drainage processes, which are characterized by extremely low resistivity. The ERI profiles image the preferential groundwater flow paths as anomalous low-resistivity areas. Groundwater is recharged preferentially by the lagoons (e.g., Lg2, Lg3 and Lg4), and the preferential flow pathways are controlled by the local hydraulic gradients, induced by the geometry of the basin and the dam itself, stratification and desiccation cracks. Noticeable is that the landslide areas (e.g., LL3 and LL4) also show low-resistivity features, even decades after 1963 (Figure 6). This is because the tailings saturate quickly but dry very slowly due to their low permeability and suction [18]. The very low-resistivity values in the vertical profile below the lagoon are consistent with other work [11,18,29–35].

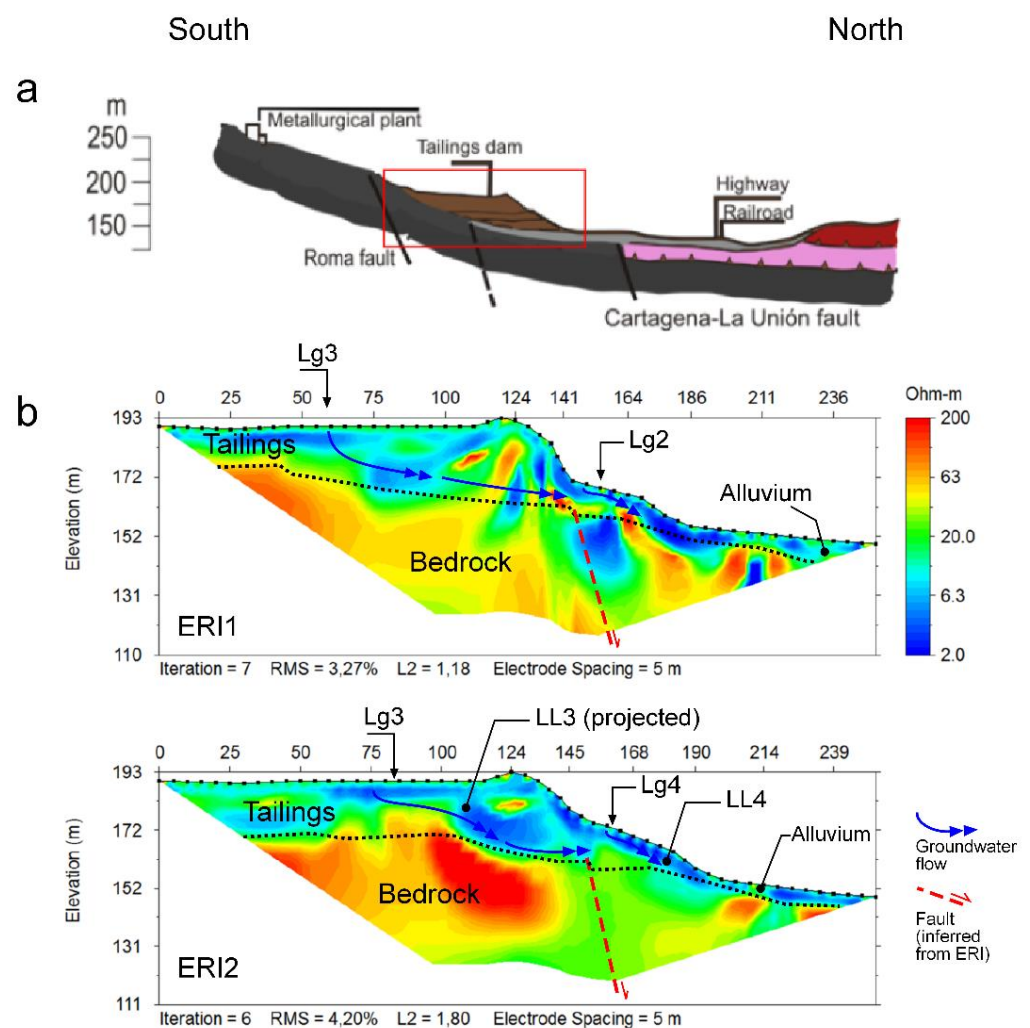
Figure 6. (a) Modeled geological profile S–N oriented along the El Descargador tailings dam emplacement. (b) Inverted resistivity images and tentative of geological interpretation of ERI1 and ERI2 collected by Wenner–Schlumberger array on the dam structure (see emplacements ERI1 and ERI2 in Figure 3a).

Therefore, we interpret the inversion artifacts as model misfits caused by rough resistivity variation gradients, which are awkwardly solved by the smoothed-constrained inversion method. Such rough gradients have been frequently related to fault areas, in different geomorphological contexts [28,58,59]. The direct observation of the fault was not possible since the area is covered by the tailings and the alluvial fans sedimented by the two ravines bordering the tailings dam. However, the break in the slope that occurs in the area—even a possible degraded fault facet is observed in the NW-sector—as well as the accommodation of the alluvial fans themselves are considered as the possible geomorphic

expression of the fault imaged by ERI, and which would form part of the East-trending fault system already mapped (e.g., Roma fault) (Figure 6a).

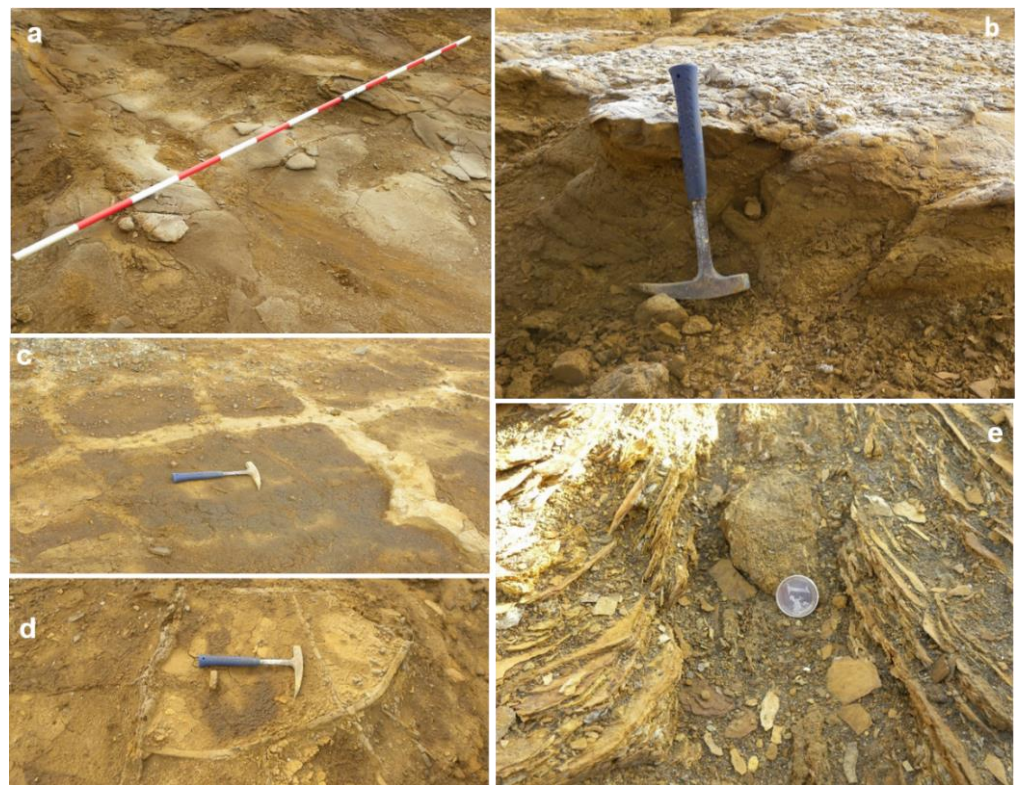
The subhorizontal interbedded sequences of tailings are crosscut by sand dikes, which are typical water-escape structures. Clastic dikes depart from the dam's foot, with a sheet thickness of 5–10 mm that expanded up to 10–20 cm during the upwelling. Interconnected sand dikes forming irregular polygonal shapes (quadrilaterals, pentagons, or hexagons), as well as sand volcanoes, are observable on the exposed surfaces along the fault planes (Figures 7–11). The textural characteristics of the tailings present in the sand dikes are very similar to the sands exposed in the trial pit. There are no sand dams and sand volcanoes in Lg2; it is because the liquefied tailings were released by Lg4, placed at the downstream, while the presence of sand volcanoes has been related to tailings dam failures [13,18,21,66–68], to our knowledge. The manifestation of sand dikes of this magnitude has not been previously reported in the literature [1,2,20,21]. The reconstructed topographic model prior to the dam failure restores the localization of the pre-existent five decantation ponds (Figures 2 and 3b).

Figure 7. (a) Massive sandy layer in the lagoon one (Lg1). (b) Detail of the atypical stratification of sand volcanoes compared with stratigraphic signature of mining tailings. (c) Sand dikes in lagoon one (Lg1). (d) Sand dikes in landslide one (LL1). (e) Detail of the sand dike emplacement, which cut crosses the subhorizontal tailings bedding.

Sediment extrusion structures, such as the sand dikes identified both in the five landslides and the sand dikes and sand volcanoes in Lg1 (Figures 7, 8 and 11), together with the conspicuous sand fraction on the surface (Figure 7a,b) do not present typical stratification of tailings, and support the occurrence of liquefaction processes. SEM observations of the mine wastes from El Descargador exhibited quite different shapes, depending on the degree of weathering and liquefaction. Differences are in the irregularity (major for P9 than W11) and surface roughness (major for W11 than P9) of samples P9 and W11 [17,71]. P9 was extracted from the test pit and is a fine-grained material (Figure 13a) with a structure unaltered since its deposition (see Figure 9b; more information in [52]). W11 is coarse-grained material (Figure 13b) from the sand dike cutting the surface of the landslide four (LL4) see Figure 9a in [71]. Therefore, W11 is a weathered post-flotation waste with a shear history of liquefaction because of a previous severe mudslide.

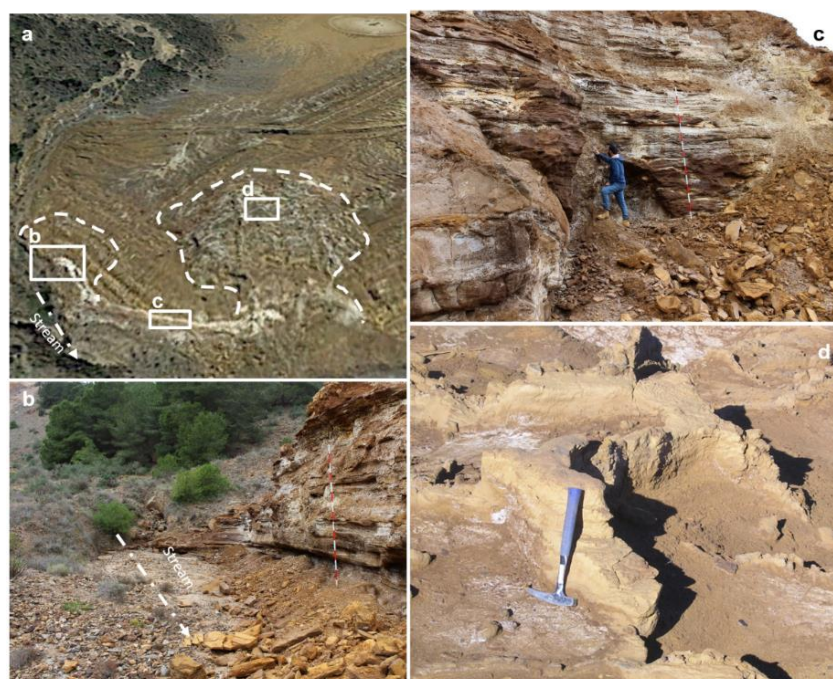
Figure 8. (a) Oblique view of landslide one (LL1) and two (LL2); the discontinuous arrow indicates the direction of the stream runoff; source Spanish National Geographic Institute-IGN and Google Earth© landslide one. Detailed views landslide one (LL1) (b) and landslide 2 (LL2) (c). (d) Sand dikes exposed on the surface of landslide two (LL2).

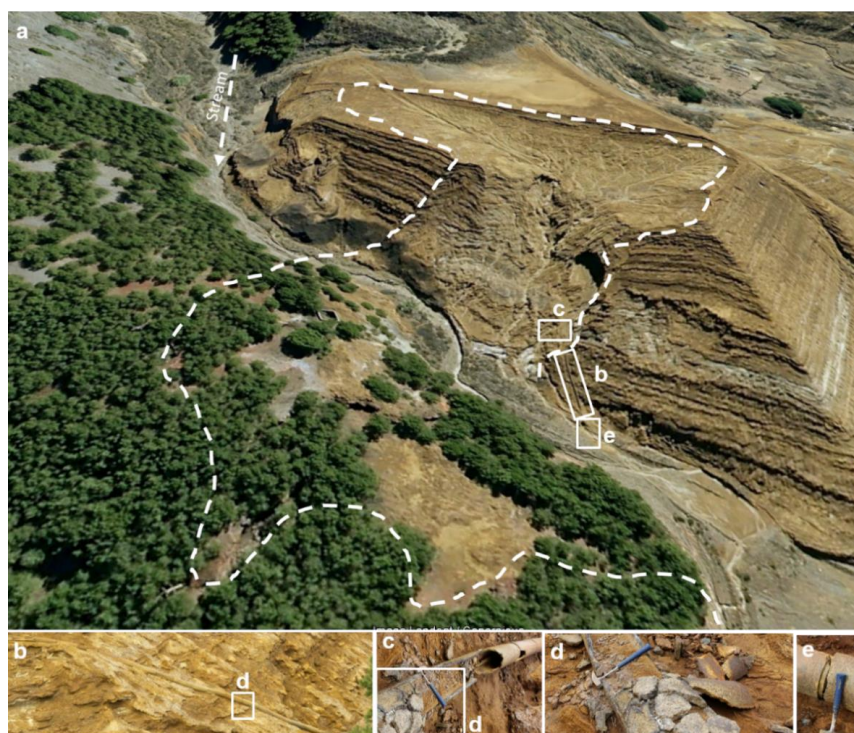
Figure 9. (a) Oblique view of landslide three (LL3); source: Spanish National Geographic Institute-IGN and Google Earth©. Note that the slid mass reached the opposite bank of the stream up to 20 m height from the channel bottom. The obstruction dammed the stream, hindering the mudflow to expand downstream. (b) Remains of the existing drainage pipe at the time of the failure. (c) Close-up views of the broken pipeline that is filled of tailings. (d) Pipeline degradation and collapse due to the inside tailings oxidation. (e) Drainage pipeline decoupling.

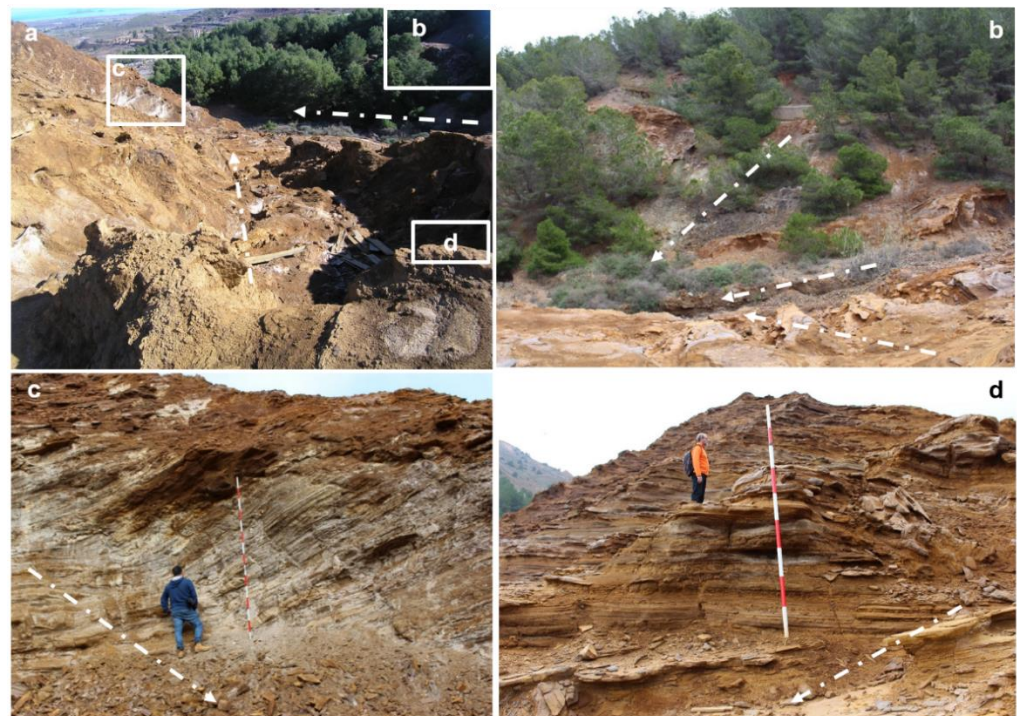
Figure 10. (a) View of landslide three (LL3) from lagoon one (Lg1). (b) View of the dam slide deposit remnants on the opposite stream bank, which caused the stream obstruction. (c) View of the tilted tailings bedding in the right margin of the landslide LL3, which is in contrast with the subhorizontal bedding of mining tailings. (d) View of the almost horizontal bedding characteristic of the tailings deposition, in the left margin of the landslide. The discontinuous arrow indicates the direction of the runoff.

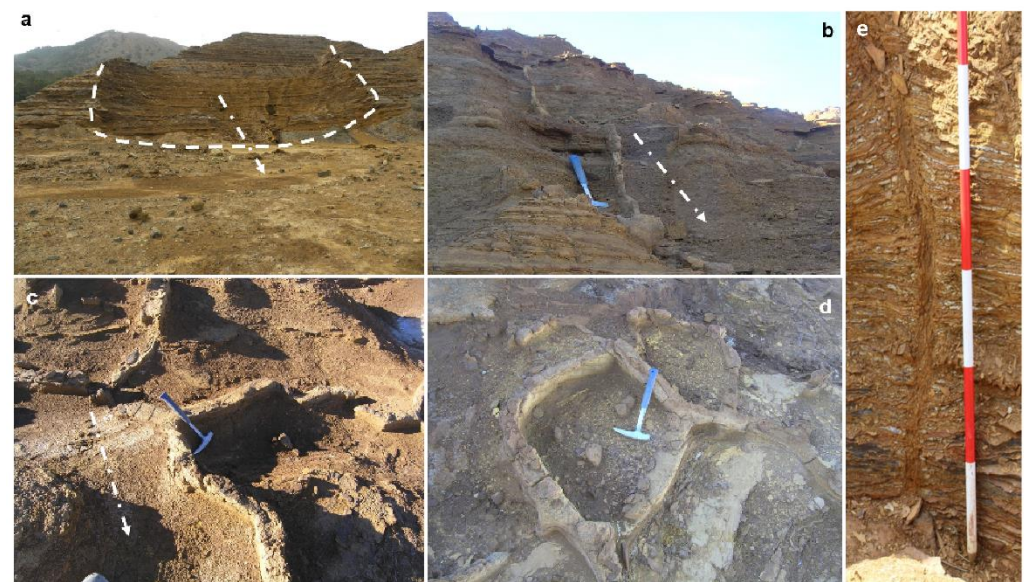
Figure 11. (a) View of the breach in the wall of the impoundment in landslide four (LL4). (b) Close-up view of a sand dike cross cutting the subhorizontal tailings bedding. Plan view of the polygonal arrangement of sand dikes on the LL4 surface (c) and lagoon four (Lg4) (d). (e) View of a sand dike exposed on the breach plane of landslide five (LL5). The discontinuous arrow indicates the direction of the runoff.

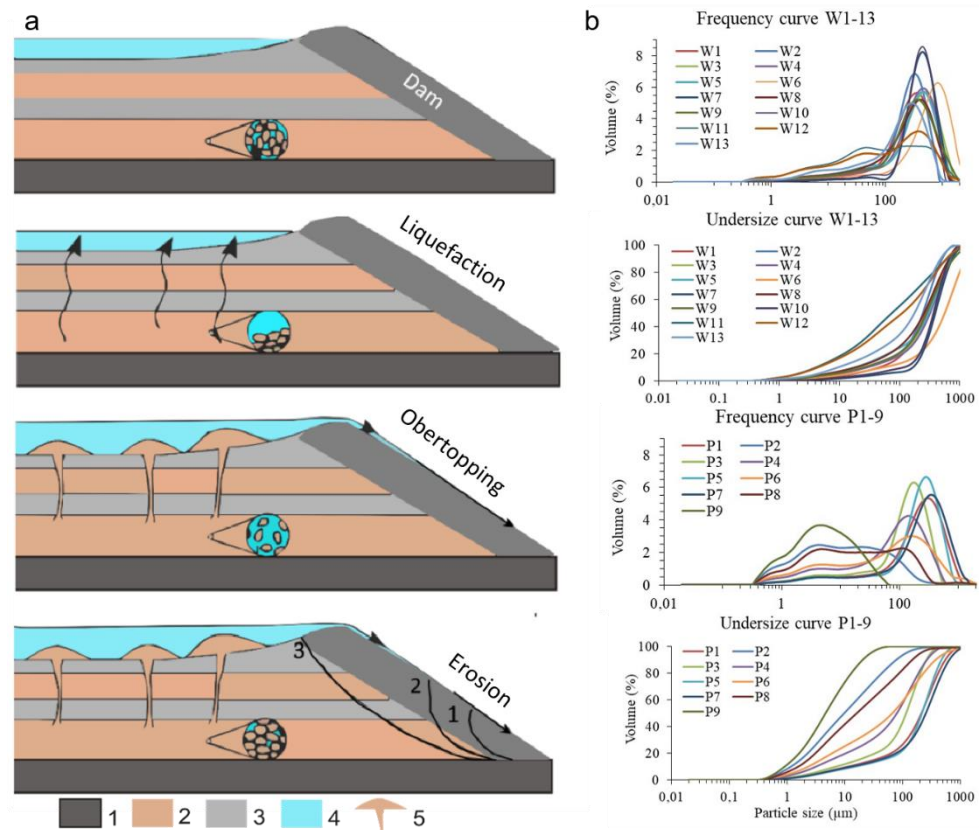
However, this rainwater stored in the lagoons would have contributed to the groundwater recharge and the rise in pore pressure and flowing, which favored the liquefaction processes. The groundwater recharge increases the saturation of the tailings and the granular material forming the foundation. The saturation of the porous material and the rapid increase of load by tailings discharge sustained over time (300 ton/day) in a small area (23,500 m²), and the rapid raising of the tailings dam (more than 4.2 m/years), caused the rise in the pore pressure and the static liquefaction of the sandy tailings (Figure 12 stage 2). The liquefied materials ascended vertically crosscutting strata of different textural and

sedimentary features and filled the decantation lagoons (Figure 12 stage 3). This implied the collapse of the structure and the overtopping of the three lagoons (1, 3 and 4) affected by landslides. The expulsion of the pore water and sediment from the beds caused an excessive water table rising in the lagoons. Consequently, the embankment overtopping and the toe of the dam become unstable by the erosion, altering the equilibrium of forces and eventually releasing the stress by the mass sliding (Figure 12, stage 4).

Figure 12. (a) Conceptual model of the “El Descargador” tailings dam flow failure. The model proposes a history of static liquefaction favored by the gain size of tailings at base levels and the rise in the hydraulic head by the effective groundwater recharge from the lagoons (stage 2). The upwelling of sands and water caused the clogging of the lagoons and the freeboards overtopping (stage 3). The flowing of tailings and water on the slopes together with the internal erosion and the pore-fluid overpressuring of the tailings mass triggered the land sliding (stage 4). 1. Basement; 2. Sandy tailings layers; 3. Silty tailings layers; 4. Water and 5. Sand dikes and volcanoes. (b) Textural features of mine tailings: samples P1 to P9, collected from the trial-pit profile and W1 to W11, collected from the sand dike from bottom to top on the surface of landslide four (see Figure 4 and Table S2).

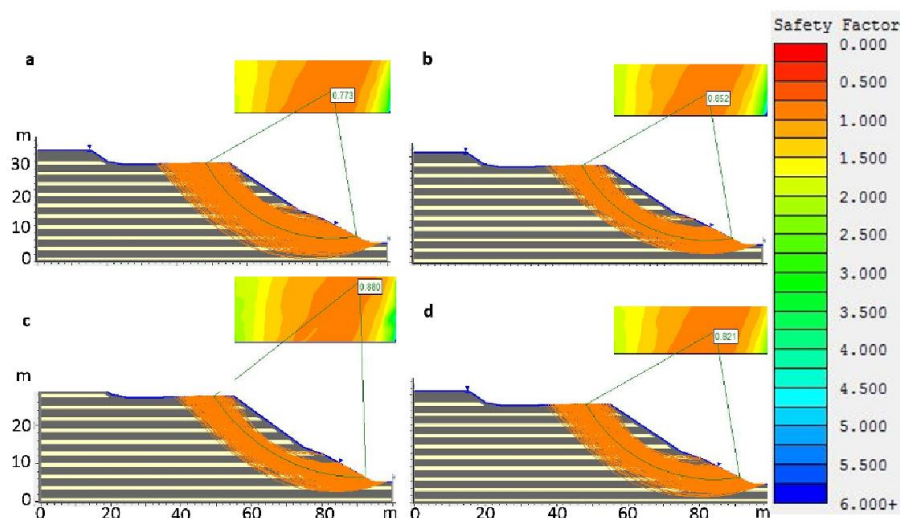
Figure 13. The graph shows all possible circular failure surfaces with a safety factor of less than one in orange; look at the vertical scale on the right and the most critical of all is marked in green. Numerical modeling of the stability factors based on the reconstruction of the topography conditions before the failure (back-analysis), considering static scenarios, with the hydraulic head set at the surface. (a) Janbu Method, (b) simplified Bishop Method, (c) GLE/Morgenstern–Price Method and (d) Janbu corrected Method.

The slope stability analysis using the reconstructed topography before the failure shows that the dam broke under static and pseudostatic for 13 boundary conditions (Table S3). The layers and dam with different thicknesses were considered. The calculation acceleration used was 0.18 PGA. The article does not show the images of the results of the pseudo-static analysis, but it does show the results in Table S3 and Figure S2. The geotechnical parameters as specific weight, cohesion, frictional angle of mining tailings were set according to Table S2 and [71]. Figure 13 shows the results of the static stability calculation for the LL4 slip. Four materials have been considered: silty tailings with the internal friction angle of 27° , sandy tailings with the internal friction angle of 29° (see Table S2), dam with the internal friction angle of 37° and foundation with the internal friction angle of 41° . The cohesion is zero. The water head was considered at the tailings dam surface, reproducing the hydraulic condition of liquefaction. This is considered a minimum since the hydraulic head could have reached even an elevation higher than that of the lagoons. The achieved numerical simulations are consistent with the hypothesis that the tailings mass sliding occurred due to a combination a dysfunction of the drainage system and static liquefaction. This concatenation of factors caused the ascent of liquefied material to the lagoon and the overflow. The debris caused the erosion of the slope and its foot which altered the stress equilibrium, leading to the tailings dam failure. The geometry of failure is, according to the model, a subcircular type landslide with stability factors ranging from 0.773 to 0.880 (less than one is considered as unstable condition; Figure 13). This geometry is consistent with a failure within the mass of tailings, which can be considered as a reasonably homogeneous material for modeling purposes. Part of the liquefied tailings can be seen on the left side of the stream (Figures 9 and 10). The released tailings caused the obstruction of the valley and the invasion of the national highway. In this regard, the damming of the stream valley had a positive impact from a hazard's perspective since it minimized the ability of the mine wastes to flow and spread downstream of the basin.

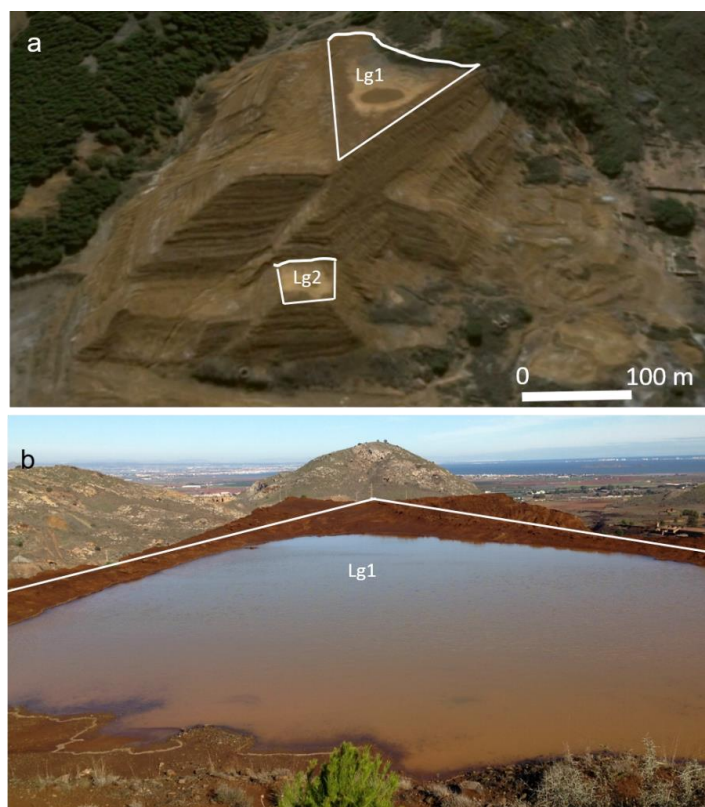
5. Geophysical modeling of the tailings dam revealed that the materials remain saturated beneath the lagoons to a 10 m depth or more, even decades after the dam failure. This observation highlights the relevant role of the lagoons in the groundwater recharge in tailings dam (Figure 14).

Figure 14. (a) Lagoon Lg1 and Lg3 after a rainstorm and (b) detail an Lg1 (October 2015). The spatio-temporal evolution of drying and wetting of the lagoons can be seen in the Google Earth clock (Since June 2002).
