Unshoring Process of a Temporary Pillar, in a Seventeen-Storey Building in Sant Adrià del Besós

Abstract: In the new construction of a seventeen-storey building, a provisional prop of fourteen-meter height, horizontally braced on two intermediate levels, has been used. Despite the fact that structural logic suggests that it can be cut without having any added safety precautions, the structure of the building, made up of cores and reinforced concrete slabs working spatially, indicates that certain mechanisms be introduced so that, in the event that different and worse behaviors than expected are detected, the process can be stopped and the consequences of the new situation observed can be analyzed. For this purpose, two pairs of four metallic cantilevers were introduced at mid-height with four hydraulic pistons. In addition, the best position of a series of strain gauges as well as transducers were analyzed. At first, a load test was carried out to check that the brackets worked correctly. Once this step was verified, the abutment was cut, and the results were read. The results of stresses and deformations were compared with those expected, always being satisfactory. Finally, four

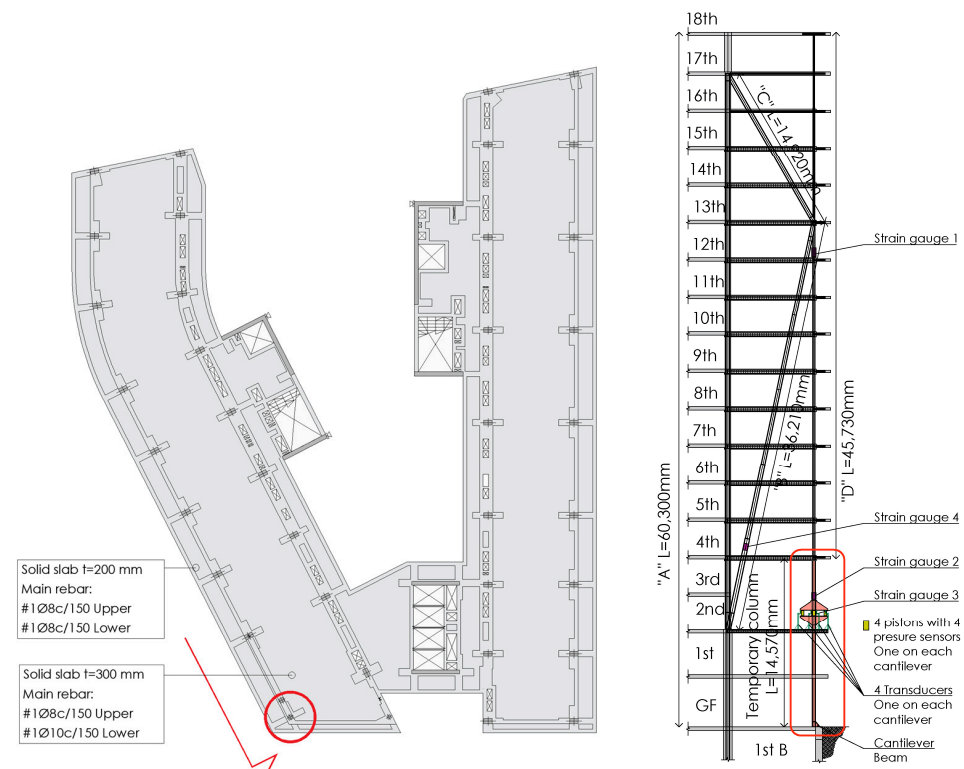
Figure 1. The image on the left shows a typical floor view of the structure. In the lower left, the provisional pillar is located in a red circle. In the image on the right, a part of the elevation of the frame that contains the shoring is shown. In the double height formed by the second and third floors, the provisional pillar can be seen, which has continuity on the ground and the first floors.

The pillar that does not have continuity is indicated in Figure 1 with a red circle; it is located in a corner of the building's floor plan. In order to complete the construction of this area, a temporary pillar was positioned. Formed with two HEM-280 steel sections, the pillar is fourteen meters high. The profiles were joined together by welding their flanges, forming a box that increased its buckling resistance. This pillar, which was the equivalent length of four stories high, rested on the end of a slab near the crowning girder of the slurry wall. An external provisional metal cantilever beam was proposed at the foot of the metallic pillar, which would be removed when the unshoring process was finished (see Figure 1 "Cantilever Beam" in the bottom right). Meanwhile, the pillar was horizontally fixed by the ground-floor ceiling and the first-floor ceiling, to work with six meters of buckling length. To fix each level, four vertical pieces of neoprene were placed on the perimeter of the hole left in each slab, maintaining contact between the slab and pillar. The temporary prop remained in service during the construction phase, until the seventeenth floor was reached. Once the main structure was completely finished, it was time to remove the prop.

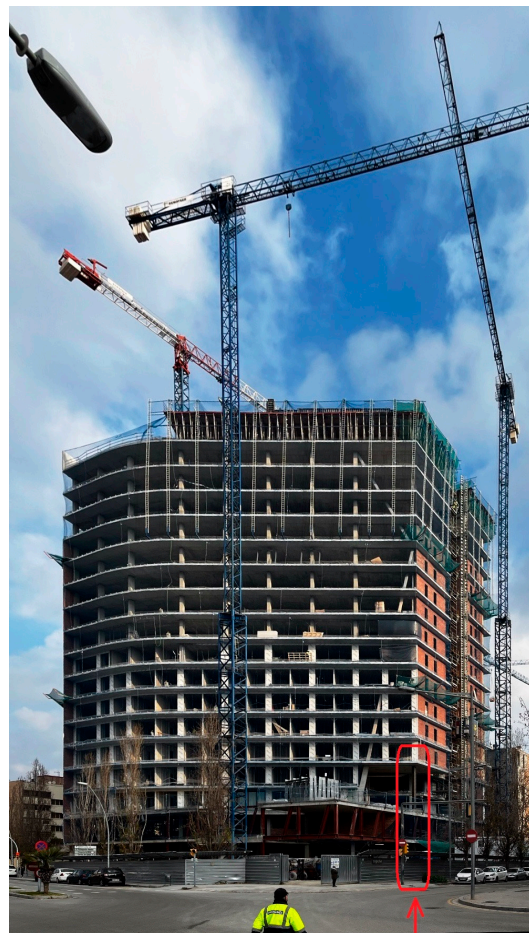
Figure 2. Image of the hotel structure completed in January 2022. You can see the temporary vertical pillar (indicated with a red rectangle), which has not yet been removed.

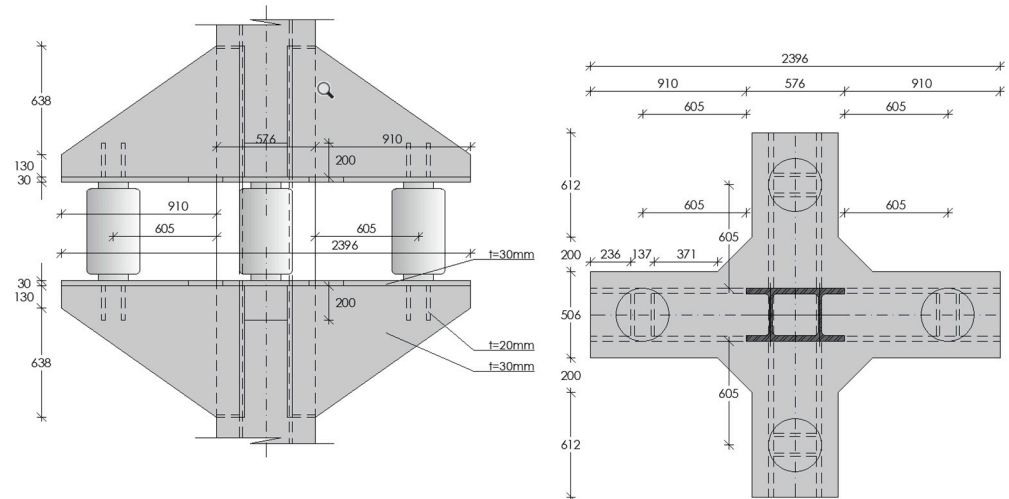
During the construction phase, the decision was made to progressively remove shoring, placing two pairs of four cantilever beams (Figure 3) in the two main directions, and on two levels separated by about 575 mm [1–4]. This distance was determined by adding the maximum deformation observed in the general calculation models, the height of the jack necessary for the required force, and finally, adding a margin in accordance with the maximum acceptable stroke. These types of techniques are commonly used in many buildings, as is the case with many historic ones [32–34].

Figure 3. Proposal for the cantilever beams, made by GMK Associates and 3Stech.

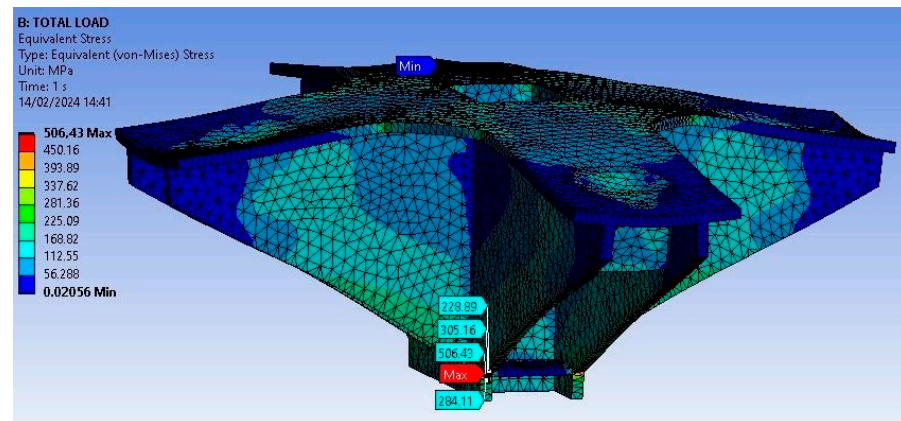
Figure 4. Analytical model of the cantilever beams. Maximum tensions in the Ultimate limit state (ULS).

- Tensions in the brackets: The stresses and the final deformations in the cantilevers were checked manually using material strength formulas [22]. In this article we use a three-dimensional model under academic license (Figure 4) that, two years later, corroborated the initial calculations of the project, always remaining below the admissible steel resistance. The deformations achieved in the cantilevers also indicate the good response of the system;

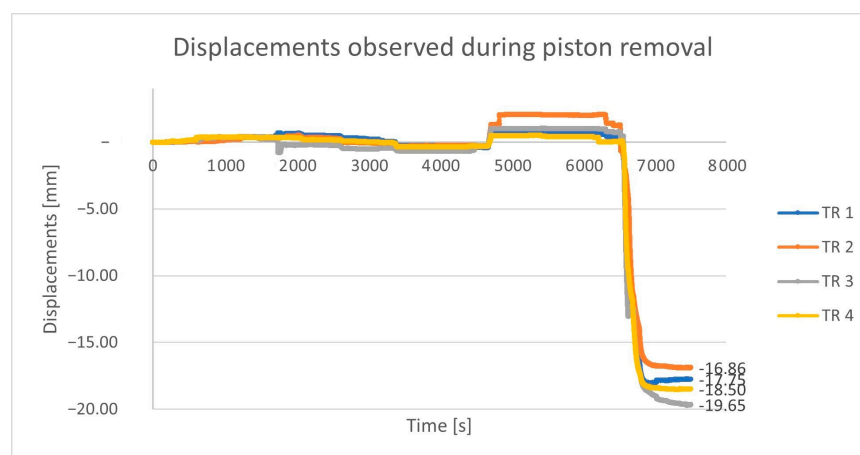
After this point and until 6500 s (108 min) of process, the movement stabilized at the previously defined figure, between -16.8 mm and -19.65 mm (Figure 5). This deformation is insignificant for the final lowered load. It also gave us an orientation of the final deformation of the shoring when the building was fully loaded.

Figure 5. Deformations were observed in the four pistons during the cutting process. The results were recorded by transducers, one placed in each piston.

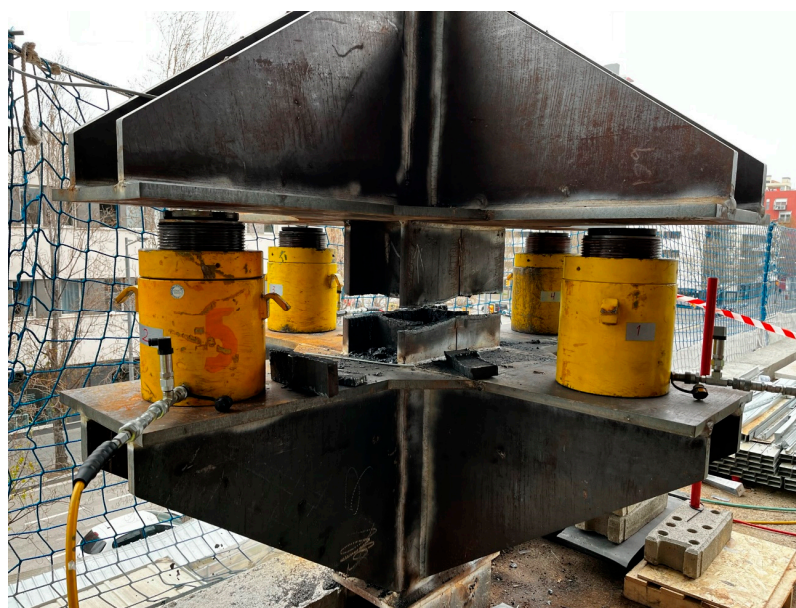
During the next day, as a safety measure, the pistons were not removed as shown in Figure 6. This decision was considered so that if the structure were to settle suddenly, subsequent corrective action could be taken, leaving the structure momentarily retained. Since the hydraulic pistons had to be used urgently on another job, and since renting more days would significantly increase the final cost of the operation, the pistons were replaced with pieces of HEB sections, leaving a separation of approximately ten millimeters from the upper cantilever beams. Thus, if the system went down due to some unconsidered problem, the piece remained stabilized without the possibility of falling.

Figure 6. Image of the system after the pillar is cut and separated from the system. In the top head of each piston, a space is visible. The transducers were removed before this photo was taken.

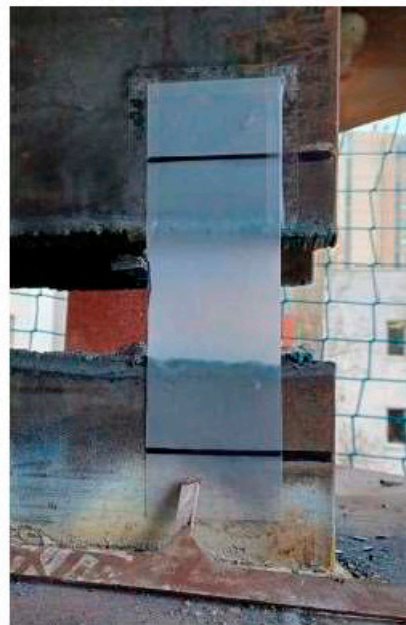
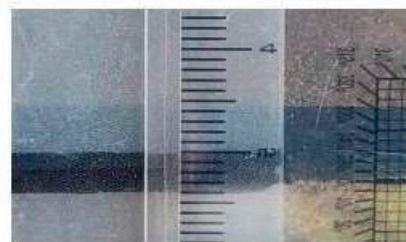
The deformations observed during the following month were variable, but in no way understood as a process without end. The changes that were collected in the reading, and can be found in Figure 7, were attributed to several factors:

- Time difference: it seemed that solar radiation might have affected some cases.
- Disposal of materials in various levels: during the days after the cut, some partition walls were built that increased the weight, and therefore the deformation of the cantilever area.
- Small inaccuracies in the measurement: although the measurement system was at all times careful and efficient, as it was not an electronic lecture system, it could contain slight deviations. It was not understood, in any case, that the results shown were incorrect. The method used to track the deformations consisted of the use of a transparent millimeter scale and the measurement of two indelible marks placed at the two ends of the cut temporal pillar.

Figure 7. Manual monitoring of the deformations made by David Sanz Engineer, head of technical office of COPCISA, during the following month after the process of the cutting process of the provisional pillar, has been completed.

- The subsequent manual monitoring of the deformations: At both ends of the cut abutment, two indelible and fixed marks (Figure 7) were placed to measure the deformations that occurred in the days following the cut. For a month and a half, a maximum deformation of 3 mm was accumulated caused by the gradual introduction of new loads in the building. The deformations varied throughout the day, possibly because the thermal expansions had a slight impact on the final result. The deformations were accepted because they were always in the expected range of less than 30 mm;

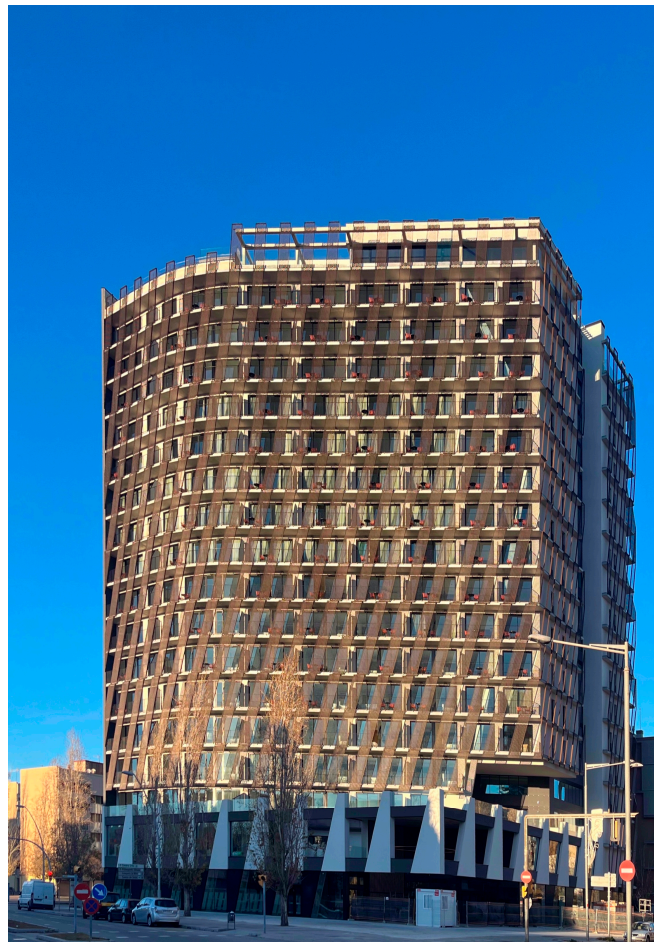
Figure 8. Image of the hotel finished in December 2023 without the provisional prop. It can be seen that the emptying of the corner favors the resulting volume making it lighter. The lower diagonal of the principal frame is difficult to locate.

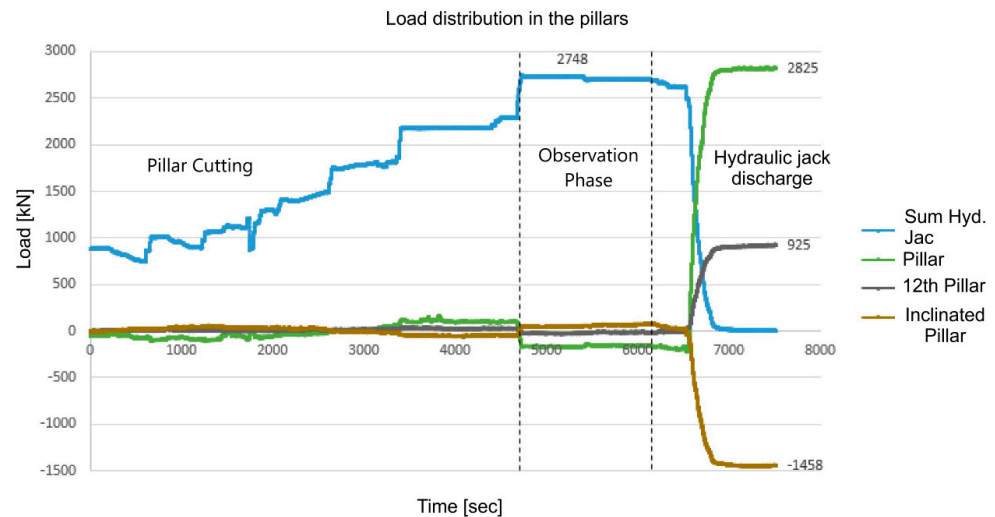
- Final monitoring of the transfer of the forces: As can be seen in the final image (Figure 9), the forces were transferred first during the cutting process of the column, then during the waiting or observation time corresponding to approximately 30 min, and finally during the unloading of the hydraulic jacks.

- a. Values corresponding to the cut provisional abutment: To cut the pillar, an initial load of 900 kN is introduced by the hydraulic pistons. As the section of the pillar is reduced—progressively removing the flanges and then the webs from the section—the load is transferred to the pistons. Figure 9 shows the evolution of the loads of the different columns monitored in the cutting of the column. It is observed that before the discharge of the pistons, the value of the load supported by the pistons, 2748 kN, is practically identical to that corresponding to that measured in the progressive discharge of the pillar 2825 kN. The difference between the two values is approximately 3%. This similarity between both values shows that the maneuver

- was being monitored correctly. The resulting load is much lower than the estimated expected 6000 kN;
- b. Values corresponding to the upper sections of the pillar (pillar corresponding to the 12th floor). It is observed how the pillar is unloaded. This must be interpreted as the axial changing sign, since initially it was compressed, and after the cut, it is tensile;
 - c. Values corresponding to the diagonal pillar: It is verified that the inclined pillar gains load. As can be seen in Figure 3, the displacements—as has happened with the loads—are markedly lower than expected: they are around 18 mm, with the expected values being in the order of 30 mm;
 - d. After 48 h of cutting the pillar, the variation in loads and displacements is checked with respect to the values measured at the end of the load transfer operation.

Figure 9. Load distribution in the pillars during the process.
