CAI FATIGUE TESTING IN CFRP: IS THE TEST REPRESENTING WHAT HAPPENS IN REAL STRUCTURES?

Davide Biagini¹, John-Alan.Pascoe¹, René C. Alderliesten¹

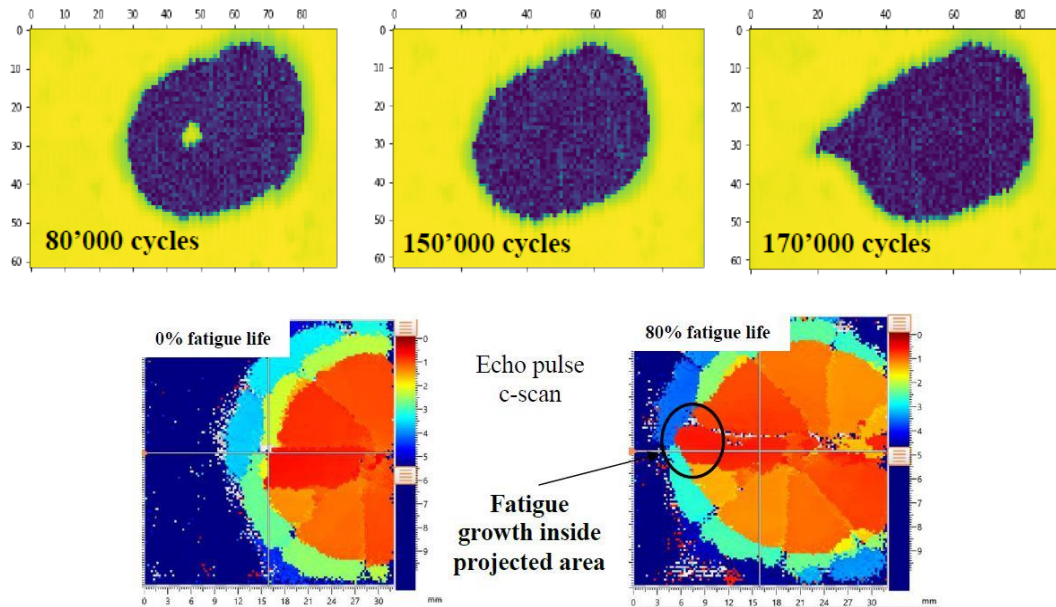
Fig. 1: Results of attenuation scan monitoring (top) and echo pulse c-scan monitoring (bottom) in different moments of fatigue life to track delamination growth (colours represent different interfaces)
