# Towards more sustainable matrices for composites at sea

*Thermoplastic composites at Ifremer*

*Mael Arhant, Maelenn Le Gall, Pierre-Yves Le Gac, Peter Davies*

*Ifremer RDT, Research and Technology Department Unit, Plouzané, 29280, France*

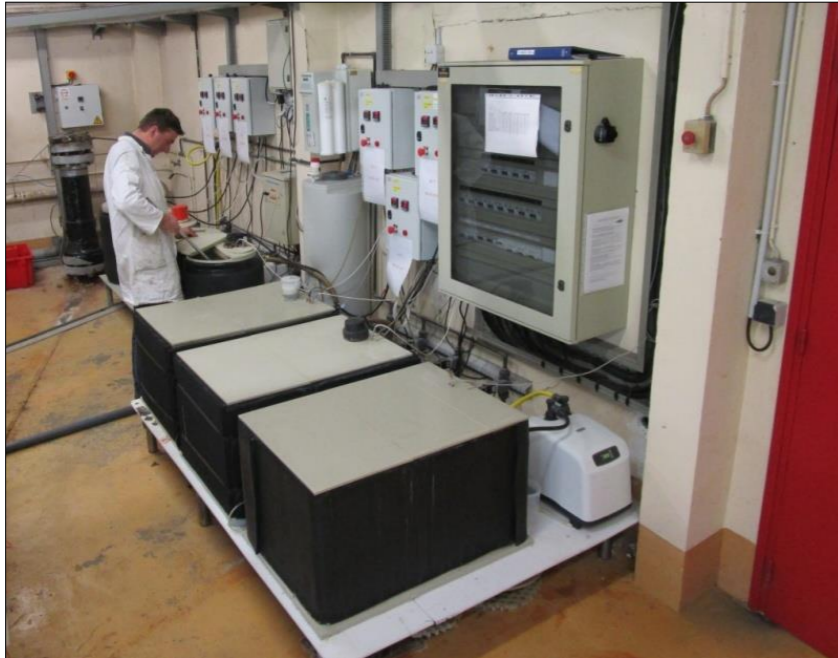
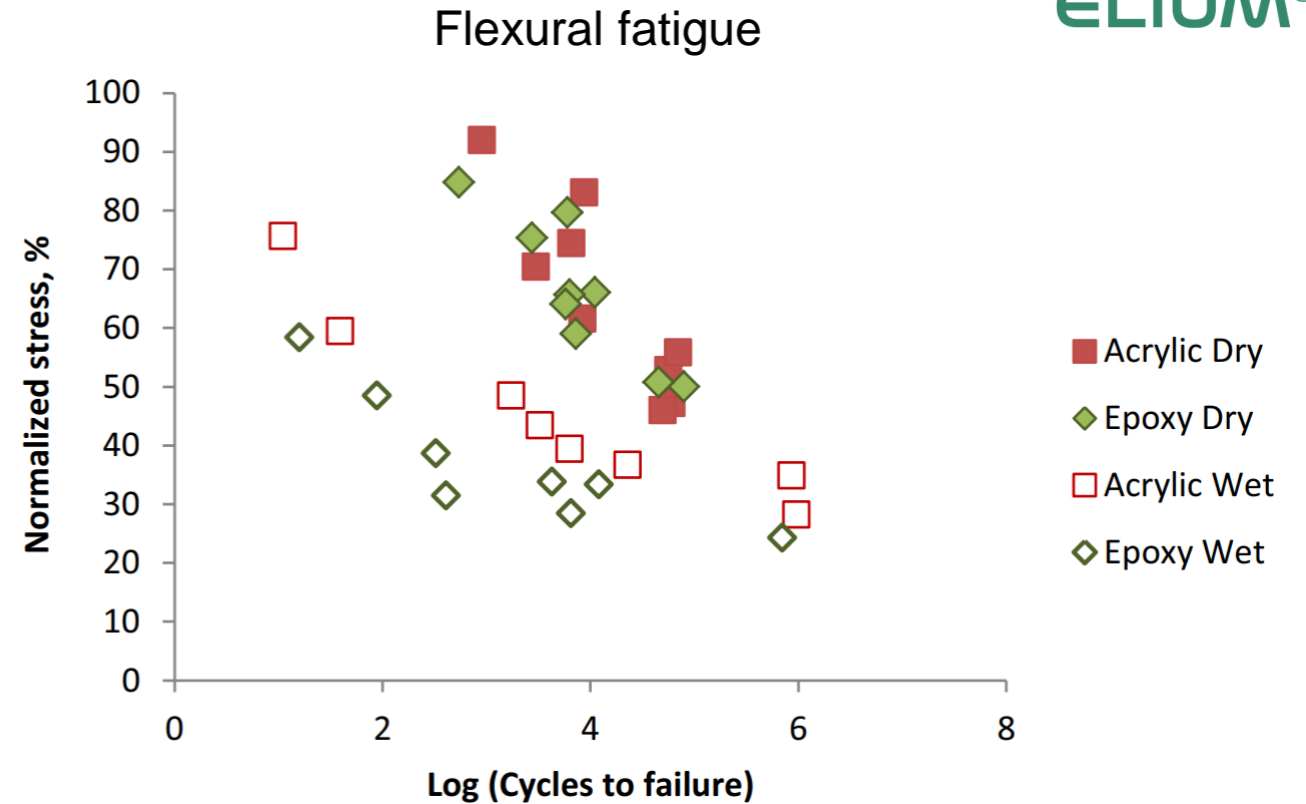
Mechanical properties after aging in sea water

Comparable/Better durability in sea water than common infusible epoxy resins

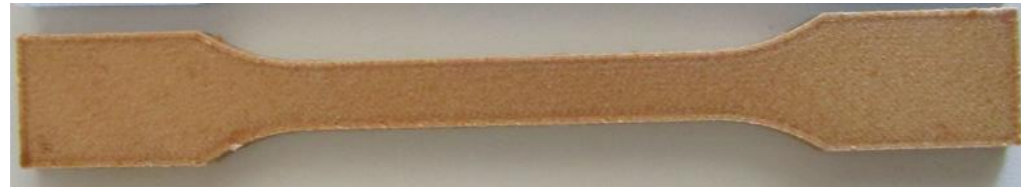
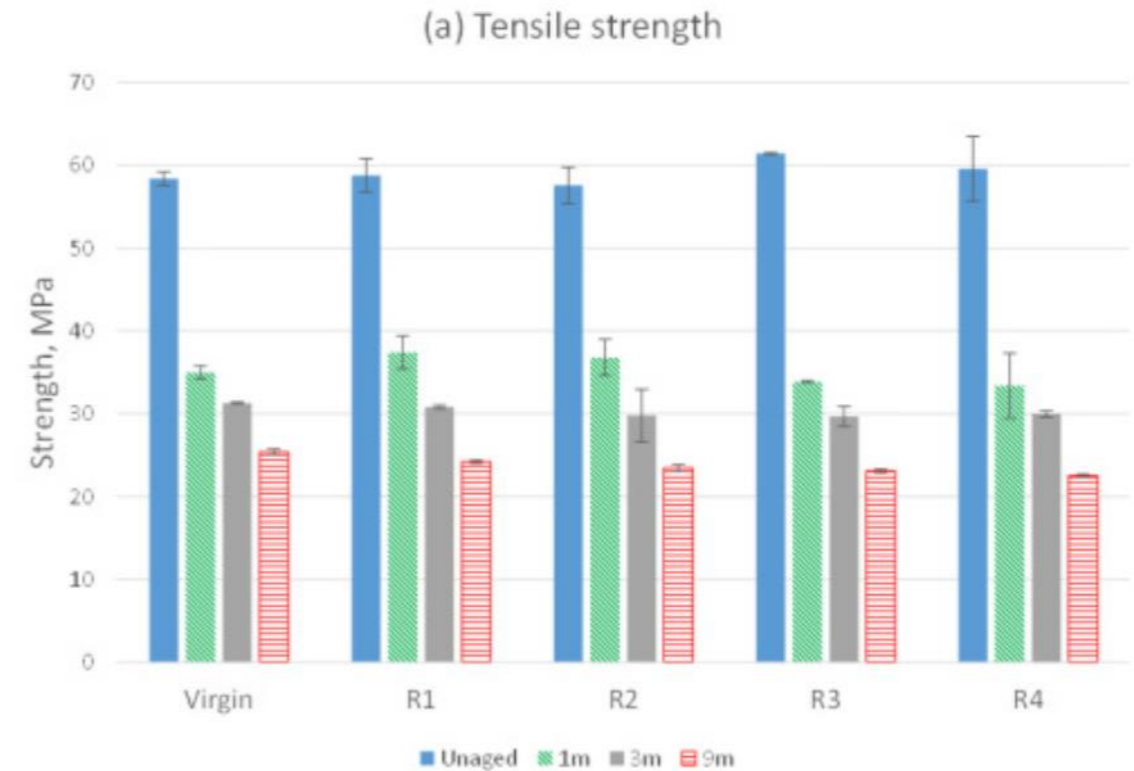
Aim: To try and produce crab pots made of flax/PLA (short fibres)

Recycled 4 times

Shredding, compounding, injection moulding

Appears possible to recycle

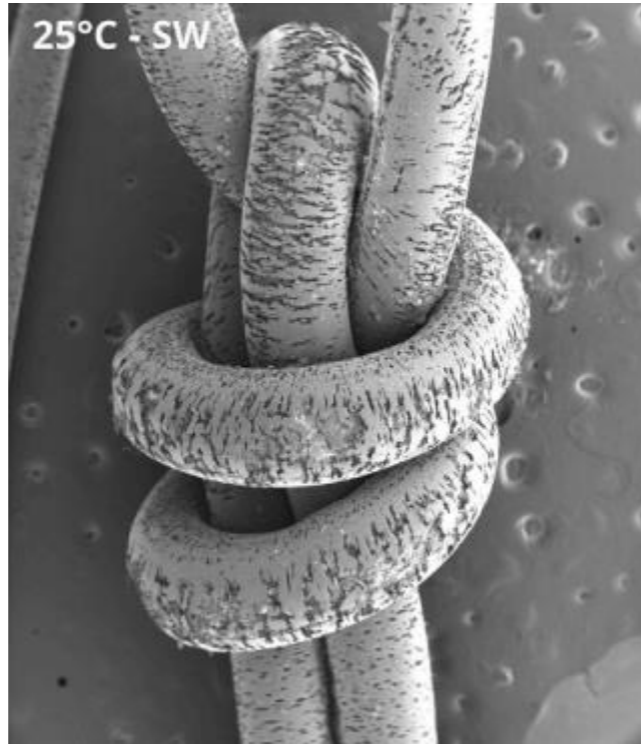
Aging at the same temperature (25°C) but different medium

Loss in Strength 50% after 240 days

Degrades due to microorganisms in sea water – Mineralized ?

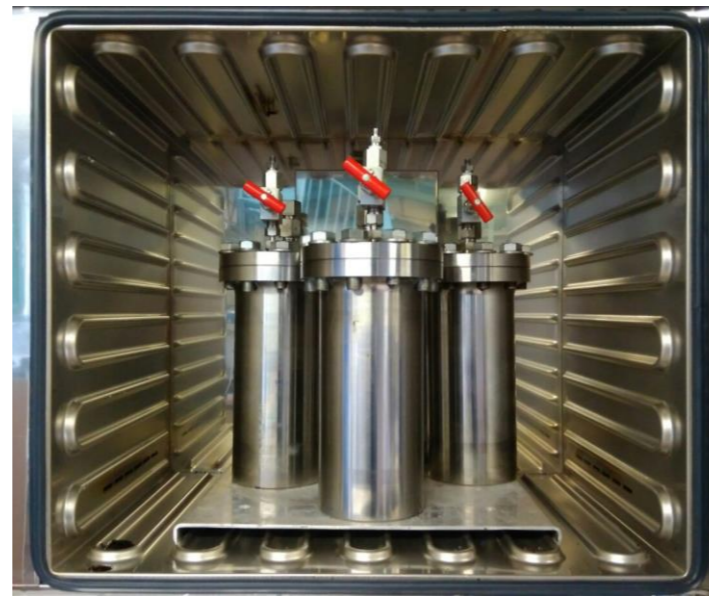
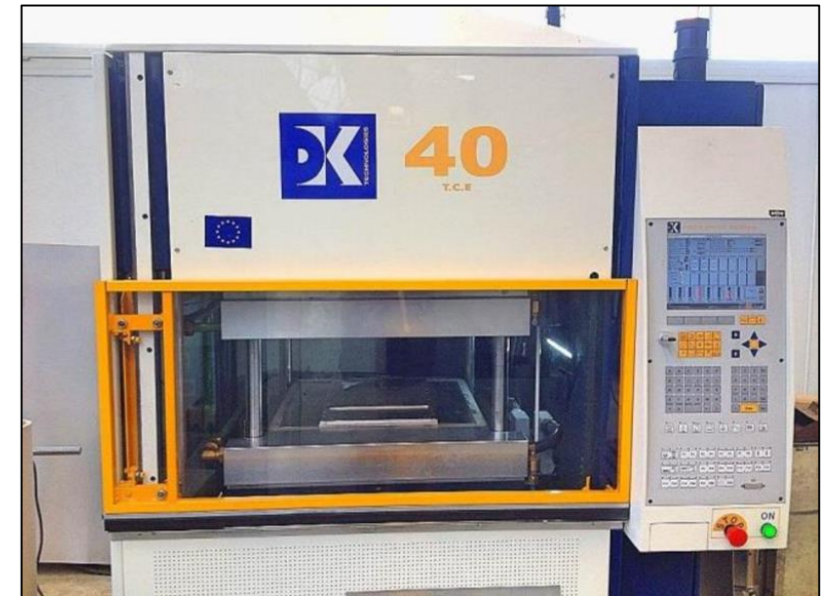
Case of C/Polyamide 6 – Unidirectional [0] DCB specimens – 5 mm thick

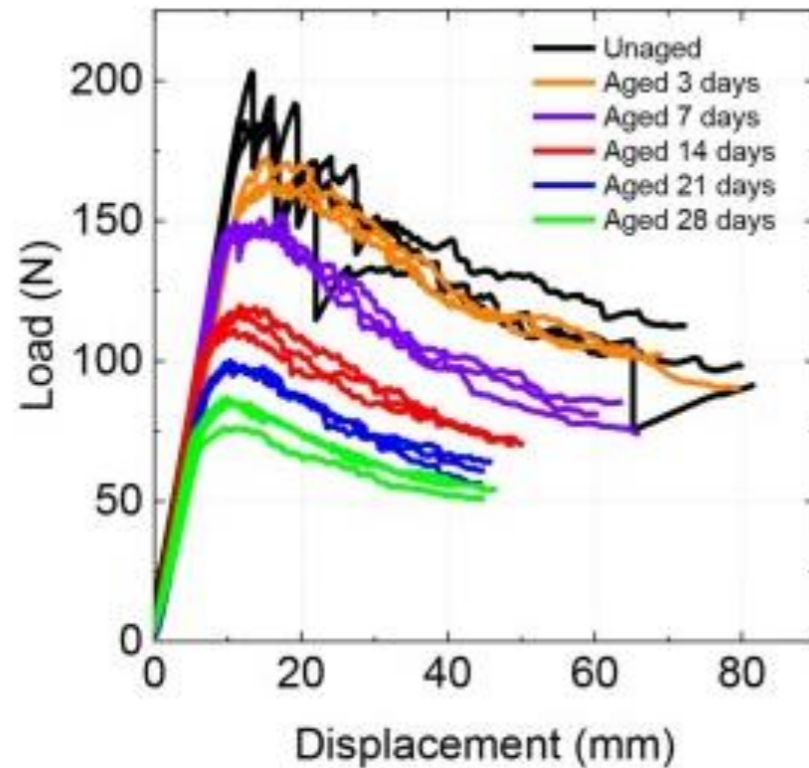
Specimens aged at 120°C in deionised water – Consequences on mechanical properties

Loss in  $G_{IC}$  induced by aging

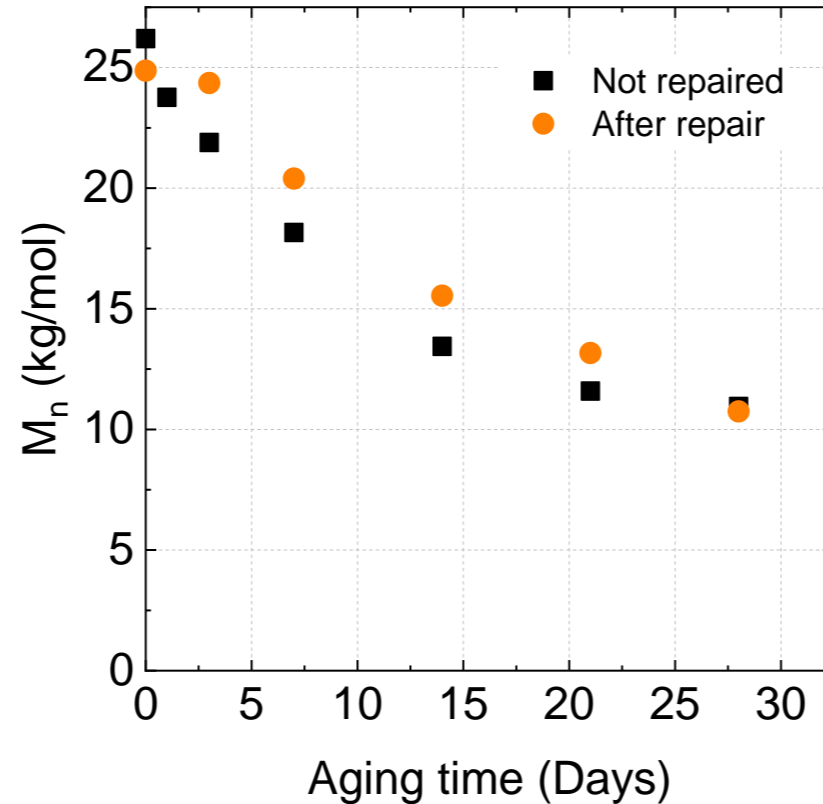
Repair using the same manufacturing cycle

Increase in  $M_n$ , Increase in  $G_{IC}$  ?
