Static Liquefaction Causes the Flow Failure of a Tailings Dam: A Case Study of El Descargador, Cartagena–La Unión Mining Region, SE Spain (October 1963)

Abstract: The aim of this work is to investigate the causes of the El Descargador tailings dam failure, at the mine district Cartagena–La Unión (SE Spain), in October 1963. Dam stability back analyses have been carried out by applying a geotechnical and geophysical approach. The failure occurred in the form of several landslides in five different points along the dam structure. The rise in the pore pressure and the steeped slopes of the tails, scaling up to 40° in some sectors, were the main causal preparatory factors. Here we propose that static liquefaction is the most plausible cause of the tailings dam flow failure. The presence of sand dikes and sand volcanoes with atypical stratigraphic architecture, both in the lagoon and at the surfaces exposed in the landslide areas, as well as the evidence of conspicuous sand fraction on the surface support the occurrence of the liquefaction processes. Major landslides were located near the drainage pipe and the flow directions were controlled by its position. Our results reveal that the

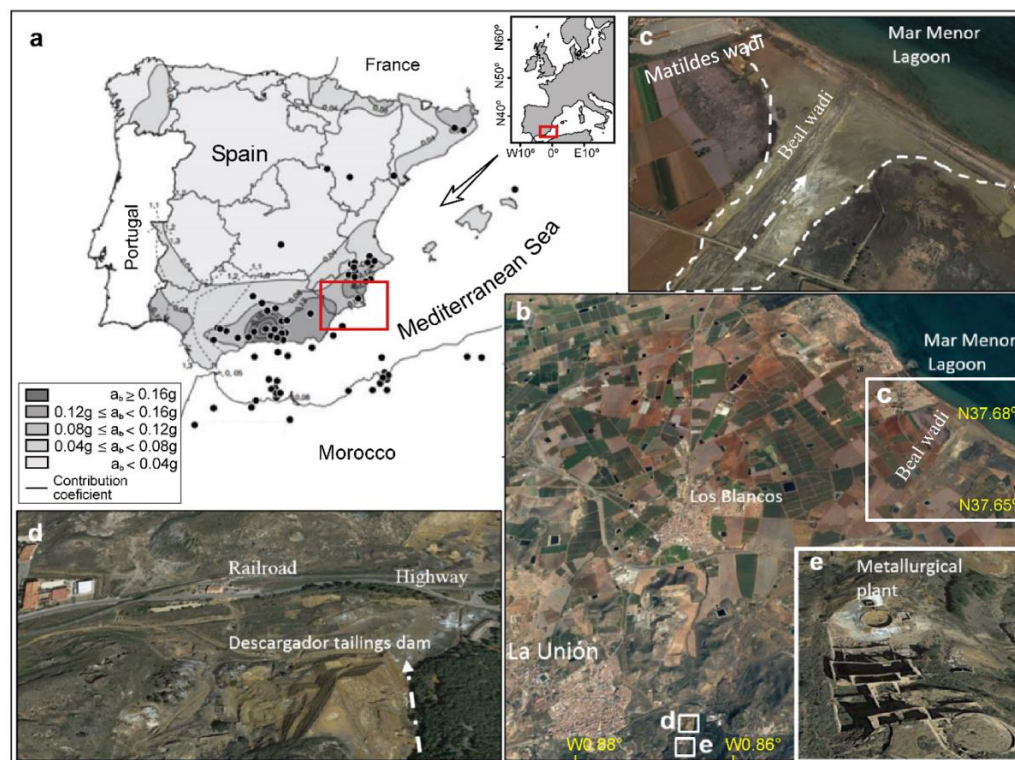
El Descargador tailings dam failed catastrophically at 7:45 on Monday, 14 October 1963, causing an environmental disaster in the Cartagena–La Unión mining district, in the province of Murcia, Spain (Figures 1 and 2). The Cartagena–La Unión mining district is part of the easternmost foothills of the Betic mountain ranges, and it is well known as a highly productive area of metals such as lead, zinc, iron, manganese and silver since ancient times [1]. The tailings dam was part of a large underground mining complex that had been in operation for more than nine years in La Unión municipality. The El Descargador tailings dam stored tailings from the Belleza mining group. This group is integrated by the following Fortuna, Felicidad, Maestra, Belleza, Resucitada, Pronta, Virgindel Carmen, Convención and Ferrocarril mining concessions. The activity of the Belleza group included the exploitation of pyrite (12%), sphalerite (10%) and galena (7%). The flotation process of the mine had a capacity of 300 tons of mineral per day. The 75% of the ore entering the flotation process was discharged into the dam as tailings. Considering the volume of daily

Figure 1. (a) Location of studied area on the Spanish seismic base map; source: NCSR-2 (2004) at Region of Murcia, (b) El Descargador tailings dam and its area of influence, (c) Beal wadis and the oxidation products of sulphides can be seen in white color in the area covered by tailings, (d) Cartagena–Cabo de Palos highway and the Cartagena–Los Blancos railroad affected by flow failure and (e) abandoned metallurgical plant. The discontinuous arrow indicates the direction of the runoff. Base maps orthorectified aerial photographs; source Spanish National Geographic Institute (IGN). Schemes follow the same formatting.

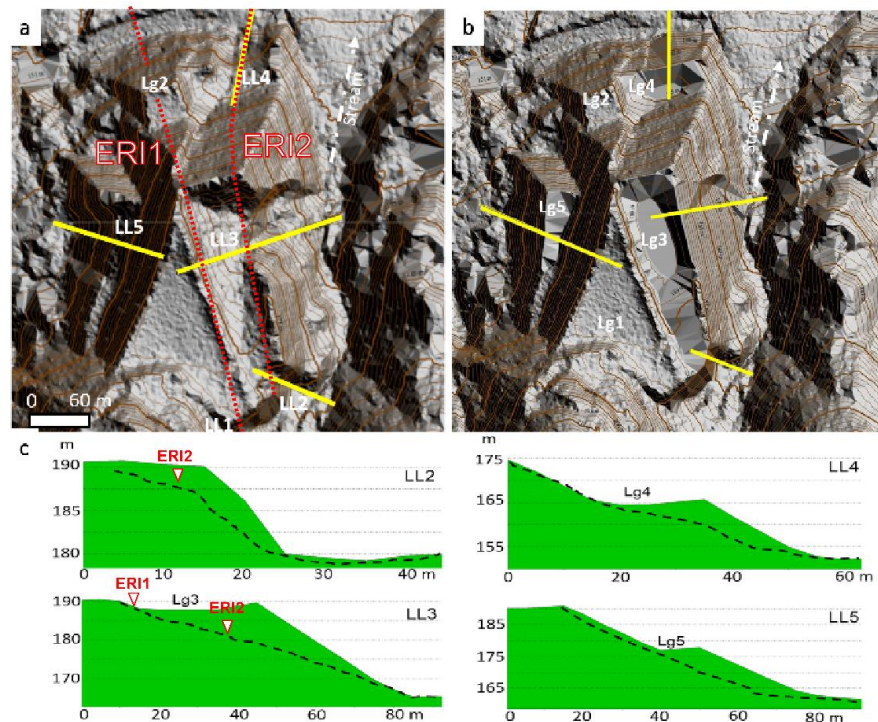
The tailings dam construction began in November 1953 and it was 42 m height at the time of the failure. The flow failure developed in five different landslide points (labeled LL; Figure 2). The height of the main landslide (LL3, Figure 3) was 27 m. 66,000 m³ of tailings and high acidic waters were released into the environment affecting: (1) an area of 4 km²; (2) different infrastructures (Cartagena–Cabo de Palos highway, the Cartagena–Los Blancos railroad); (3) the watercourse of Beal wadis stream; and (4) the El Mar Menor lagoon, an area of great ecological and patrimonial value in the Mediterranean Sea. Catastrophic mine tailings dam failures are increasing globally [2–12]. However, while the study of its ecological and socioeconomic consequences has been widely addressed in the literature [11–17] studies, attempts to address the hydro-geomechanical factors that caused the failures are scarce [18–20]. There is still more uncertainty regarding historical failures of dams that happened many decades ago, as is the case of El Descargador. This is an important gap of knowledge, since more than 80 uncontrolled old dams have been inventoried in this mining region [20]. The study of the causes that triggered and controlled the failure and collapse of ancient tailings dams such as El Descargador can provide valuable information to be considered in the design and management of such installations and its associated hazards, which are instrumental for the success of any mining operation.

Figure 3. (a) ERI profiles layout on a hill shaded elevation models of El Descargador tailings dam; (a) actual state; (b) tentative reconstruction of the relief before the 1963's failure; and (c) Representative topographic profiles of the main landslide before (green) and actual surface of failure dashed lines. The white dashed arrow indicates the stream runoff direction.

The reconstructed topographic model prior to the dam failure restores the localization of the pre-existent five decantation ponds (Figures 2 and 3b). The flow failure directly affected four of these lagoons (Lg1, Lg3, Lg4 and Lg5), which stored a large amount of water at the time of collapse. The lagoons had a little freeboard not exceeding 2 m (Figure 3). The flow failure of the tailings dam took place in five different points (Figures 2 and 3). Landslide LL1 (Figure 2) caused a breach in the wall of the impoundment 10 m wide and 6 m high, through which about 2000 m³ of tailings slurry were released to the stream. LL1 affected a small section of lagoon 1 (Lg1, Figure 2). The water runoff eroded the slope and part of the foot of the dam, where it is still possible observing the contact between tailings and underlain quaternary and metamorphic materials. The landslide LL2 (Figures 2 and 3) breached the impoundment wall along 30 m wide and 15 m high, and 5,000 m³ of slurries reached the stream. Here, whitish precipitation compounds produced by the oxidation of the sulphides, mainly magnesium sulphates, still coat some sectors of the exposed slope surfaces. Landslide LL3 (Figure 2, Figure 3, Figure 9 and Figure 10) was the biggest and the only one where a drainage pipe was installed. The movement of the sliding mass from LL3 came to obstruct temporarily the stream channel. LL3 caused a breach 60 m wide and 27 m height, and ca 50,000 m³ tailings flowed up to temporarily dam the stream channel and buried the drainage pipe. The inspection in 2015 revealed that a drainage pipe was filled with tailings, before the sliding, suggesting that the obstruction and failure of the drainage system contributed to the dam slope destabilization. Some noticeable stratigraphic unconformities characterize LL3 deformation upstream. In LL3, some up to 30° dip-tilted tailings beds are juxtaposed to subhorizontal other ones. It should be noted that settling slopes for tailings dams are majorly in the order of 1 to 2°. In the north, LL4 breached the impoundment along 35 m wide (Figure 2, Figure 3 and Figure 11) and released ca. 6000 m³ of tailings. The lack of topographic impediments favored the flowing and sedimentation of mining slurries along a surface of 0.2 km². Landslide LL5, in the west, depicted a similar behavior compared to LL4, with a breach of 40 m wide and the mobilization of ca. 3000 m³ of tailings along 0.3 km². In general, the tailings dam is an irregular pyramidal structure, with platforms and lagoons distributed at different elevations.

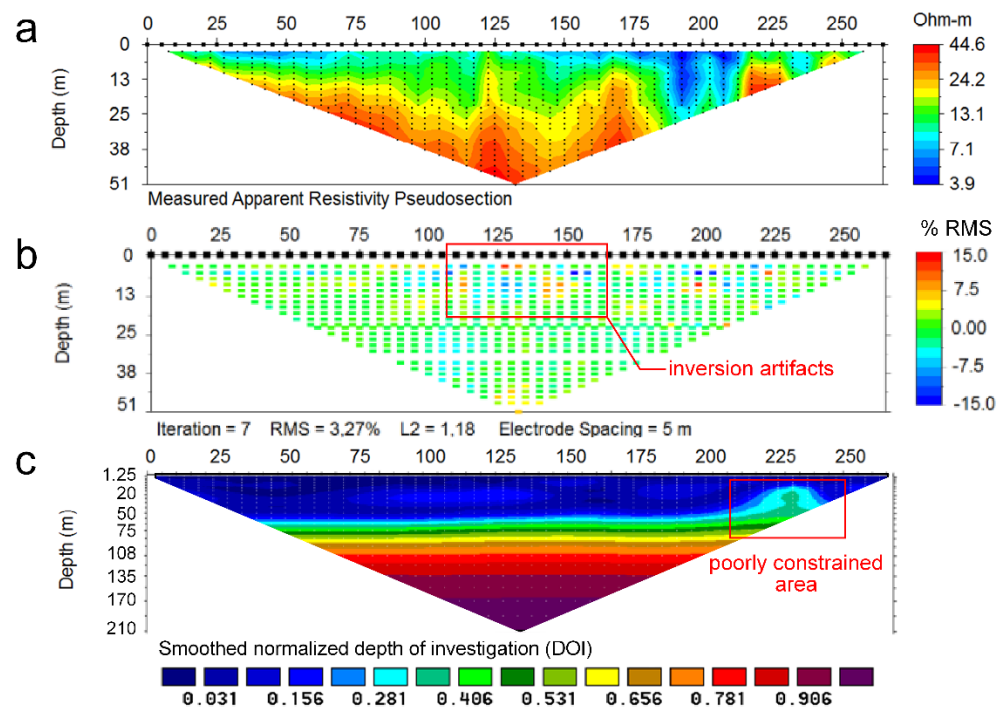
More rigorous cutoff criteria were not imposed, since some features are interpreted as inversion artifacts that could offer relevant information on the presence of fractures [28,57–59]. The final model residuals do not exceed an RMS of 5%. On the other hand, the DOI-index was computed with Res2DInv software (Geotomo) to identify the depth at which the resistivity images were poorly constrained by the data [60]. Two constant resistivity-starting models of 0.1 and 10 times the average of the measured apparent resistivity were used for the calculation. The average of apparent resistivities was 17 Ωm (ERI1) and 16 Ωm (ERI2) in this case. Several authors advise a DOI cutoff value of 0.1 to 0.2 or, alternatively, considering the limit according to the maximum gradient [60,61]. Based on both criteria, it is possible to identify poorly constrained sectors, as those located in the northern sector of ERI1, at position $x = 250$ m (Figure 5c), which should be interpreted with extreme caution.

Figure 5. Quality assessment of the ERI1 profile, (a) recorded pseudosection, (b) Data misfit pseudosection representing the relative data error between the calculated and the measured apparent resistivity records (model residuals), (c) Depth of investigation index (DOI) computed as the difference between subsequent inversions setting the starting models to 1.7 and 170 Ωm, respectively.
