Experimental characterization and numerical modeling of damages induced by low-velocity impacts in recent composite materials

S. Chaibi, F. Laurin, J. Rannou, J. Berthe
C. Bouvet

Context of the study

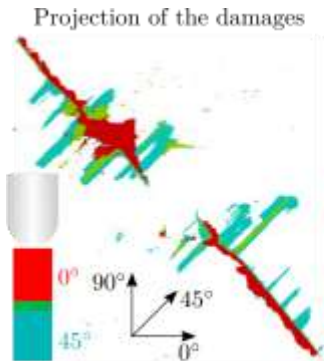
Damage assessment

- Intraply delamination triggered at the edge of the fibre kinking
- Micrographs show a high amount of damage networks near the rear face

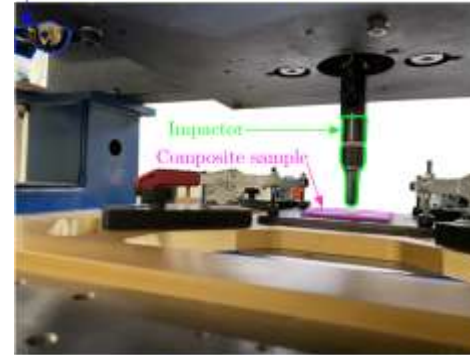
Medium-speed infrared camera (CEDIP)

- Modification of the existing setup
- 2 high speed IR cameras
- 2 high speed visible cameras
- Observation of impacted and rear faces
- Mandatory to establish damage scenario

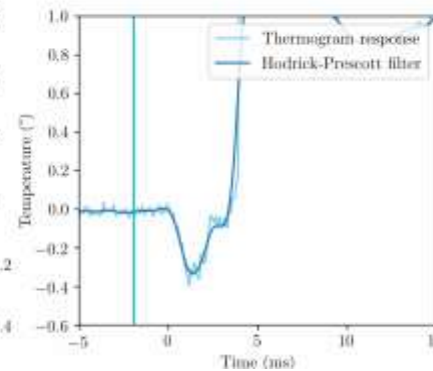
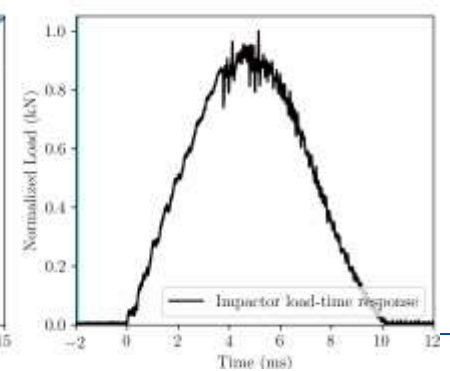
Rear side

High-speed infrared camera (TELOPS)

High-speed optical cameras x2 (FASTCAM)

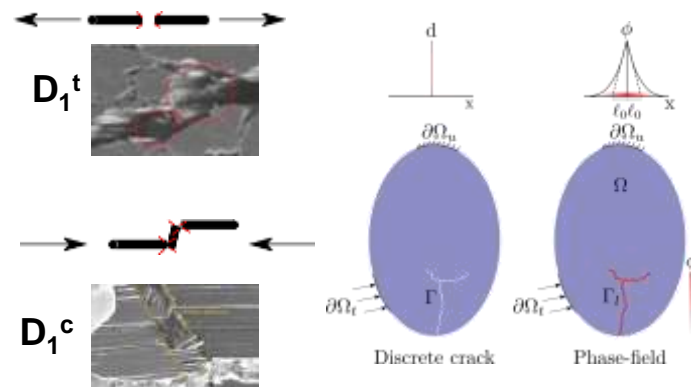
Fibre failure modelling

- 2 different fibre failure variables (1 tension/1 compression)
- Phase-field variational failure approach (anisotropic formulation)

$$\mathfrak{E}_{\text{bulk}}(\varepsilon, \phi) = g(\phi) \frac{1}{2} \varepsilon^t \mathbb{C}(\phi) \varepsilon = (1 - \phi)^2 \frac{1}{2} (\sigma_{11} \varepsilon_{11} + 2\sigma_{12} \varepsilon_{12} + 2\sigma_{13} \varepsilon_{13})$$

- Alternate resolution (mechanical and phase-field)

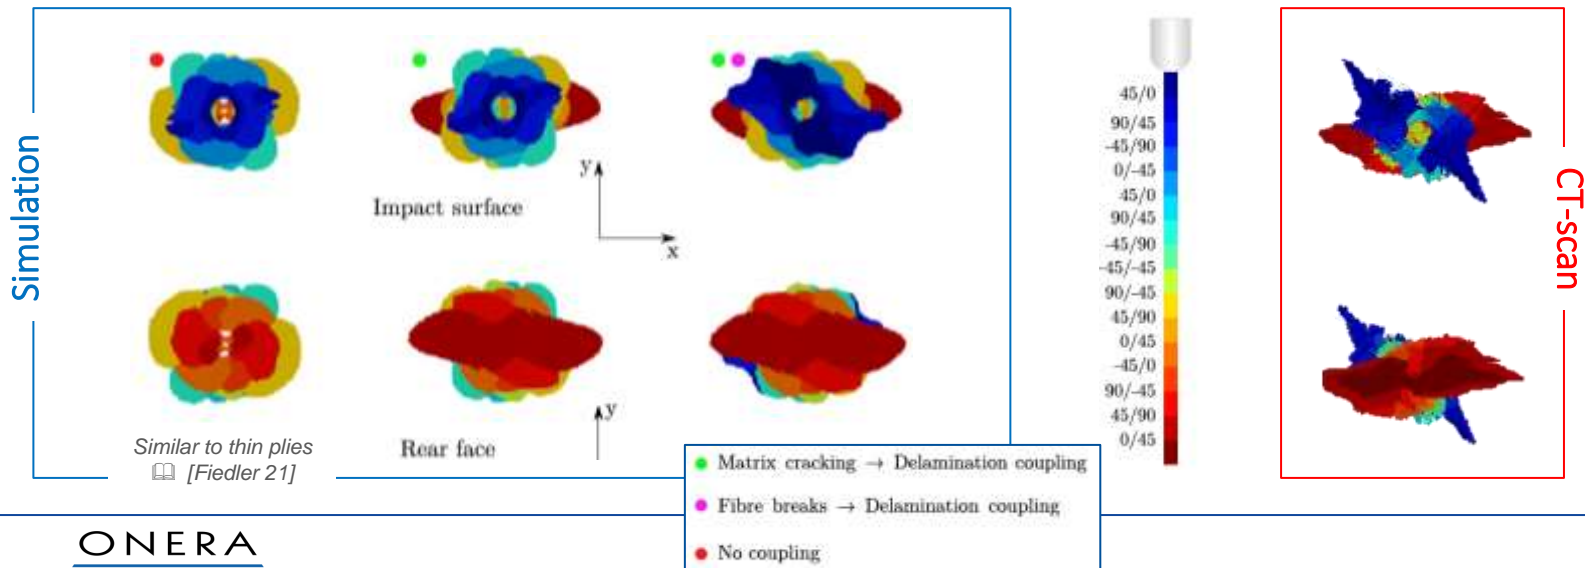
Damage pattern explanation

- Analysis of the damage pattern for a QI laminate impacted at 21J
- Reinforcement for combined shear/compression explains absence of damage under striker
- Strong effect of coupling between delamination and intra-ply damage mechanisms

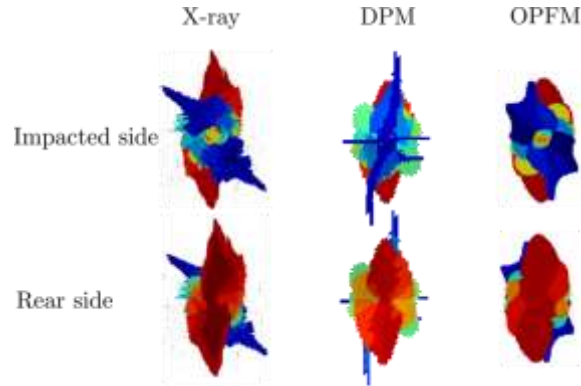
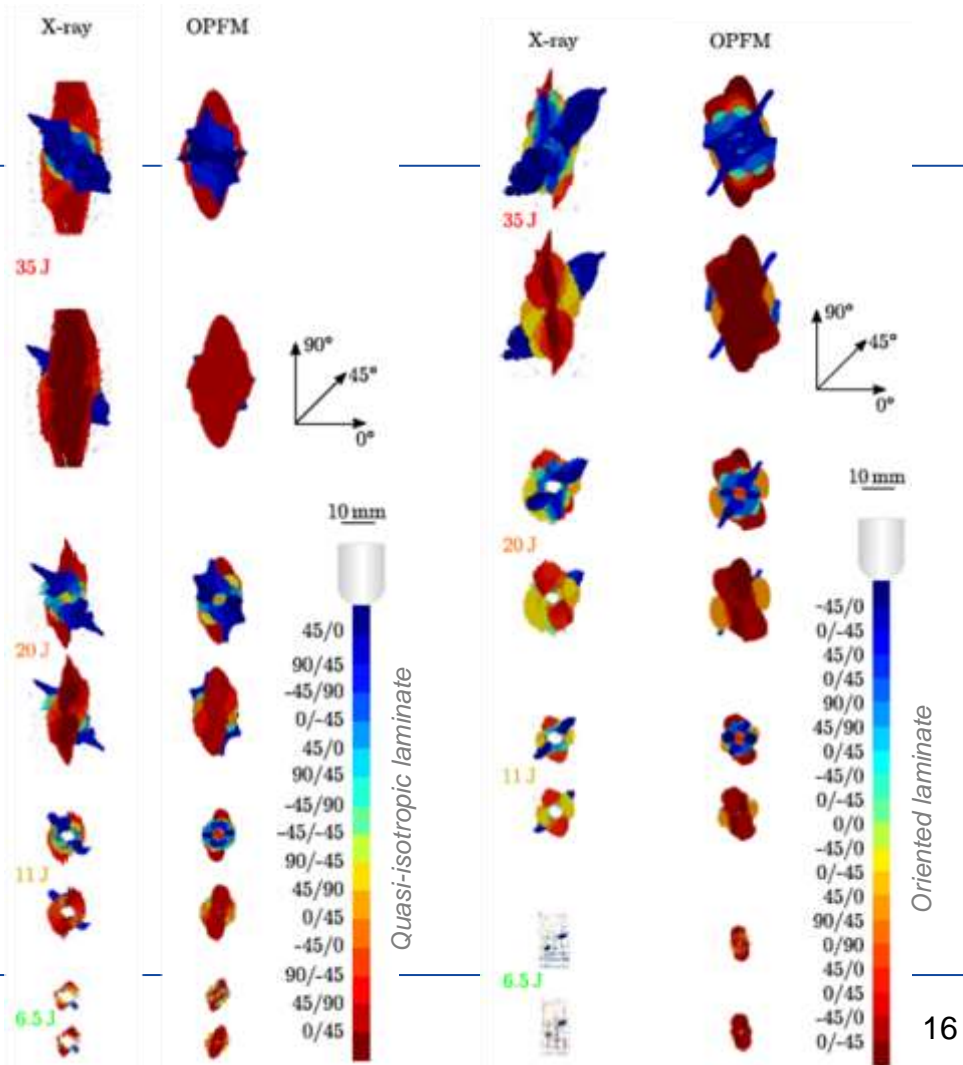
Predicted damaged area

- Good agreement between tests and simulations performed with OPFM (ONERA) and DPM (ICA)
- At 35J prediction of DPM model is better due to coupling trans. cracking/delamination
