Variable-Stiffness Composite Panels: Defect tolerance under in-plane tensile loading

O. Falcó^a, J. A. Mayugo^a, C. S. Lopes^b, N. Gascons^a, J. Costa^a

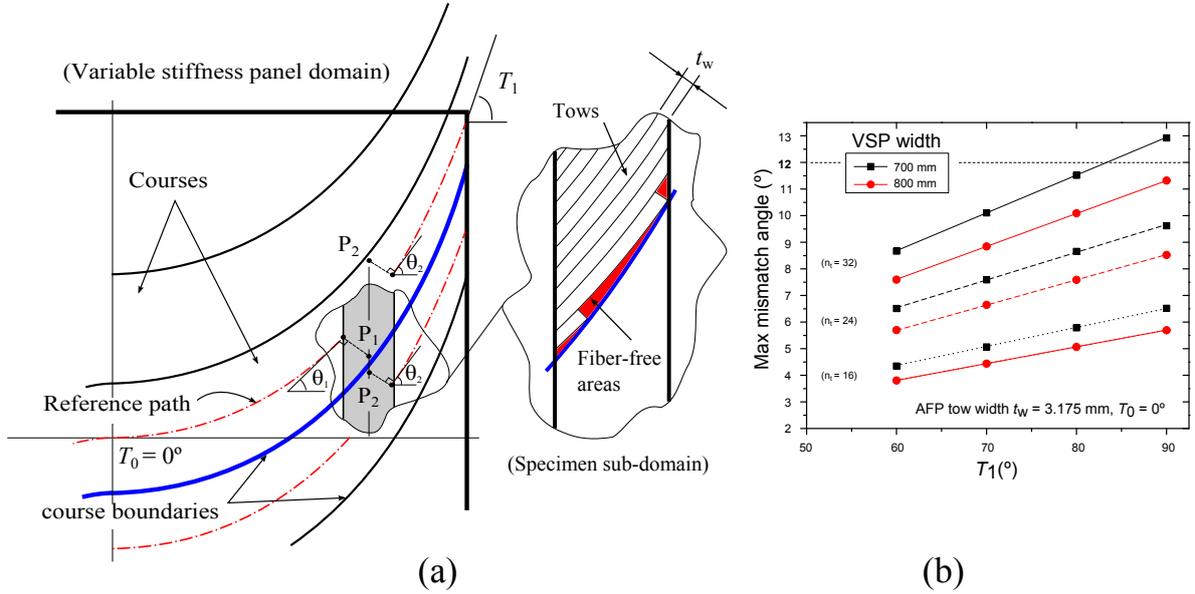
Figure 1: a) Tensile specimen sub-domain definition in a Variable Stiffness Panel. b) Maximum mismatch angle ($\theta_1 - \theta_2$) between the boundary of the courses for panels of 700 mm and 800 mm for $T_0 = 0^\circ$ and different T_1 values.

The test specimens for the experimental work reported in this paper have been designed to represent the ply discontinuities at the edges of adjacent courses in VSP configurations. Accordingly, each specimen represents a sub-domain of a whole panel, as shown in Fig. 1a. The maximum tow-angle mismatch ($\theta_1 - \theta_2$), represented in Fig. 1b for different VSP configurations with linear fiber-angle variations, is dependent on panel dimensions, course width (or number of tows per course, n_t) and fiber angles at the center (T_0) and at the edges of the panel (T_1) [3]. In Fig. 1b only those configurations with $T_0 = 0^\circ$ are considered, as these lead to the worst-case tow-angle mismatch scenarios. Likewise, a panel side of 700 mm in the direction of fiber-angle variation is considered as a limit case. For a panel smaller than this, the maximum variation between T_0 and T_1 would be bounded by the minimum machine turning radius in order to keep an acceptable laminate quality. Hence, a maximum theoretical mismatch angle of 13° is achieved. In reality, the angle $T_1 = 90^\circ$ is never achieved

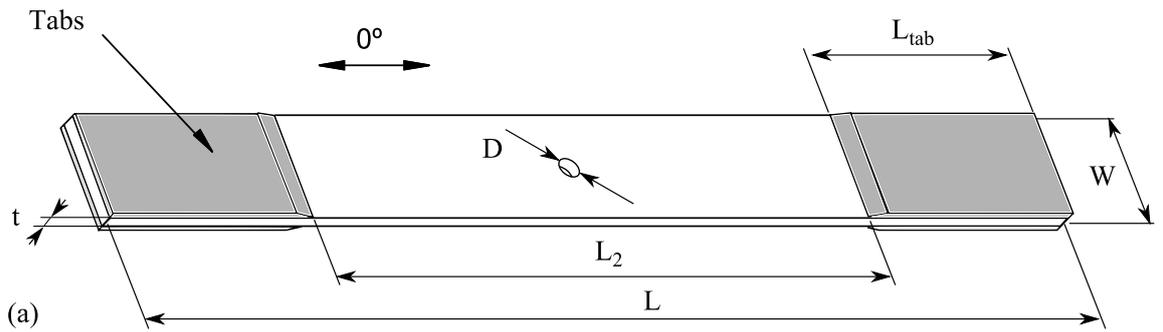
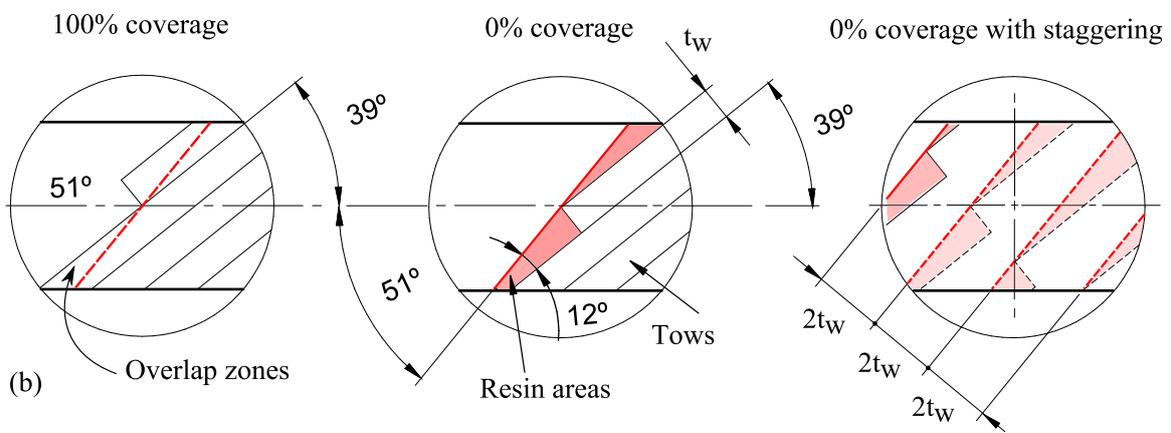
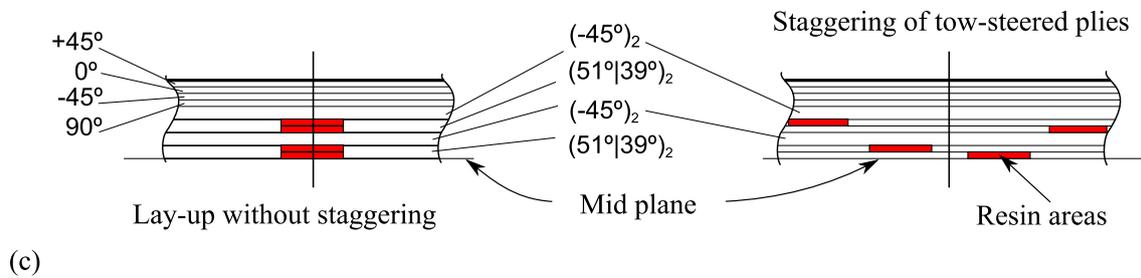
Figure 2: a) Specimen geometry. (b) Tow-drop gap defects (100% gap coverage, 0% gap coverage and 0% gap coverage with staggering). The discontinuity interface in the ply $\langle 51|39 \rangle$ is represented using a red line and resin rich areas are shaded in red. (c) Tow-drop specimen lay-up with and without staggering.

The specimens consist of straight-fiber layers since, considering the small dimensions of the specimens, there is negligible difference between the actual curved trajectory and a straight one. Some layers in the laminate have one portion with the fibers at 51° and another at 39° , thus creating an angle discontinuity at the specimen mid-length. To avoid more complexity, these plies with angle discontinuity were balanced with plies at -45° . Both the Un-Notched Tensile (UNT) and the Open-Hole Tensile (OHT) specimens have the same outer dimensions: length (L) of 310 mm, width (W) of 32 mm and tab length L_{tab} of 65 mm. The specimen geometry is depicted in Fig. 2a.

Three configurations with tow-drop defects have been designed and tested. The configurations are described in Fig. 2b. The difference between the three is in the variation of the gap coverage parameter and the use of the staggering technique. In one configuration, tows are cut avoiding any overlapping, hence generating a triangular fiber gap (0% gap coverage). In another configuration, tows are allowed to overlap by just the required amount to avoid these gaps (100% gap coverage). As a result, right-triangular gaps or overlaps appear in the laminate. The dimension of one leg is the width of the tow and its opposite angle is the discontinuity angle (see Fig. 2b). In our case, the triangle legs are 6.35 mm and 29.9 mm respectively. In these two configurations, gaps and overlaps are co-located through the thickness of the laminate for plies with the same steered configuration. In a third configuration, the co-location of gaps is avoided by staggering the plies in relation to each other. The staggering distance is twice the width of the tow (12.70 mm) along the transverse direction to the 51° tows (see Fig. 2b).

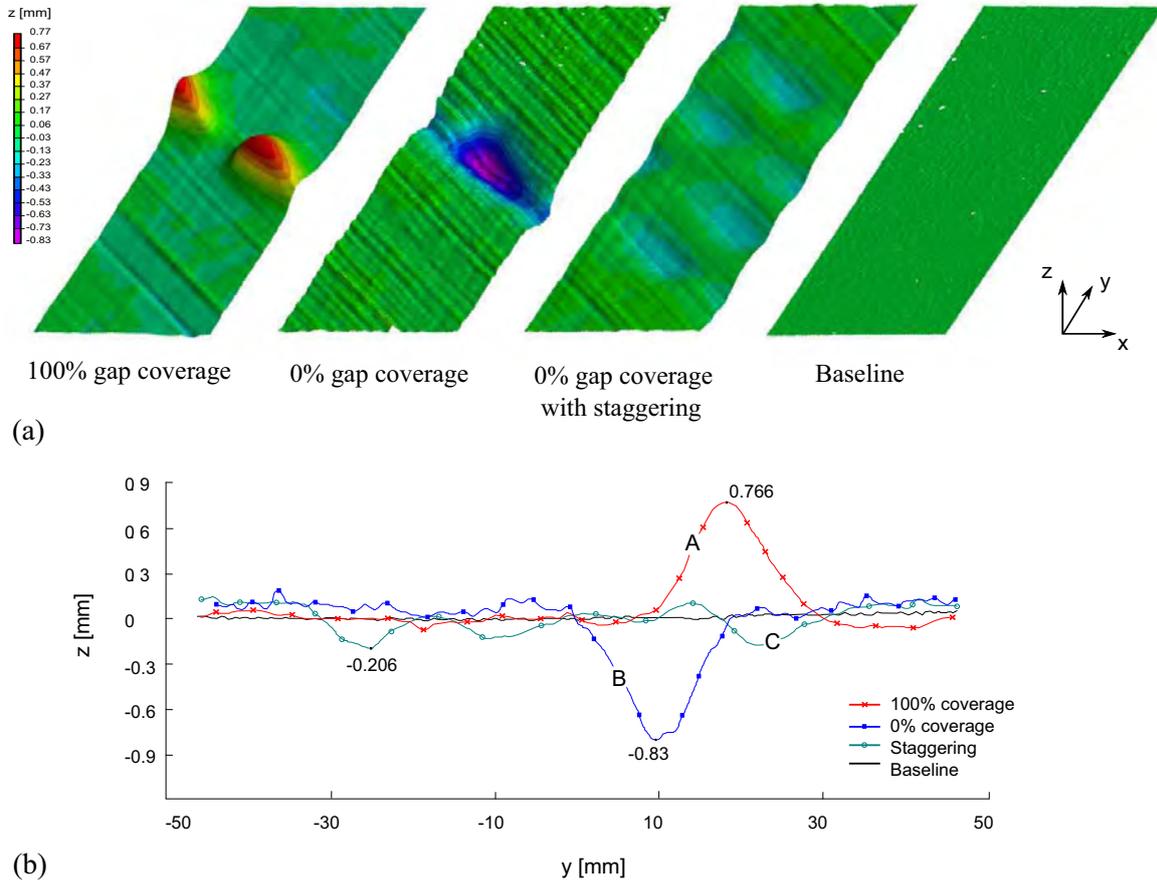
Figure 3: Profile variations on top surface of the different specimens configurations.

The real top-surface profile and dimension measurement for each configuration is precisely obtained with the VIC-3DTM system. A comparison of the surface profile in the top outer layer for each configuration is shown in Fig. 3. The thickness variations along the y -direction of the middle line for the different configurations are compared. For the configurations without ply staggering, the tow-drop defects coincide at the same in-plane location for layers of the same configuration, which produces co-location of overlaps and gaps. For the configuration with 100% gap coverage, the laminate thickness increases by 15% due to the overlapping. Whereas, for the configuration with 0% gap coverage, the maximum thickness reduction is 20%. This thickness reduction is caused by the pressing of gaps in adjacent

layers as a result of the high pressure in the autoclave during the curing process. However, if the staggering technique is applied, the local thickness variation reduced considerable ensuing in a mere 5%. The reason being that staggering reduces the superposition of defects through the laminate thickness.

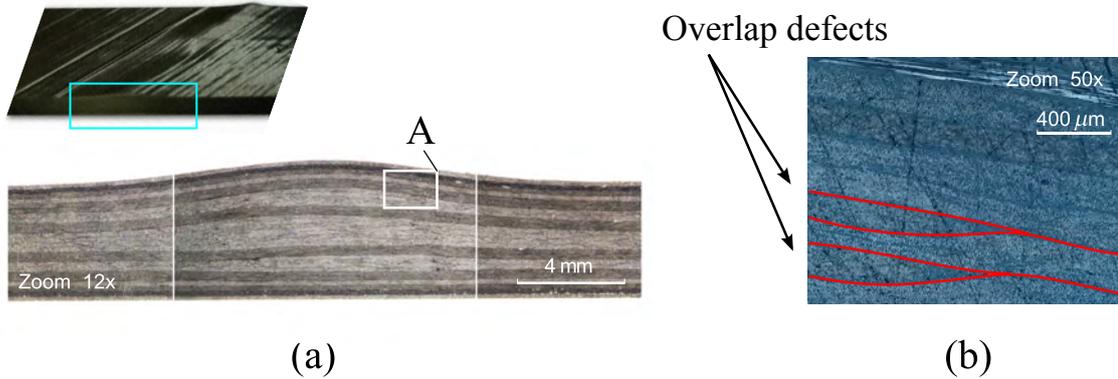
Figure 4: a) Real tow-drop defect for configuration with 100% gap coverage (magnification $12\times$). b) Detailed micrography (magnification $50\times$).

For the configuration with 100% gap coverage, an external and cut view of the specimens analyzed are shown in Fig. 4. The increase in thickness due to the ply overlapping is remarkable. The curvature of the outer layer is smooth (see Fig. 4a) as a result of the stiffness of the continuous layers during the curing process. The manufactured specimens contain significant areas of overlap, together with small triangular rich resin zones near the tow-drop sections (see Fig. 4b).

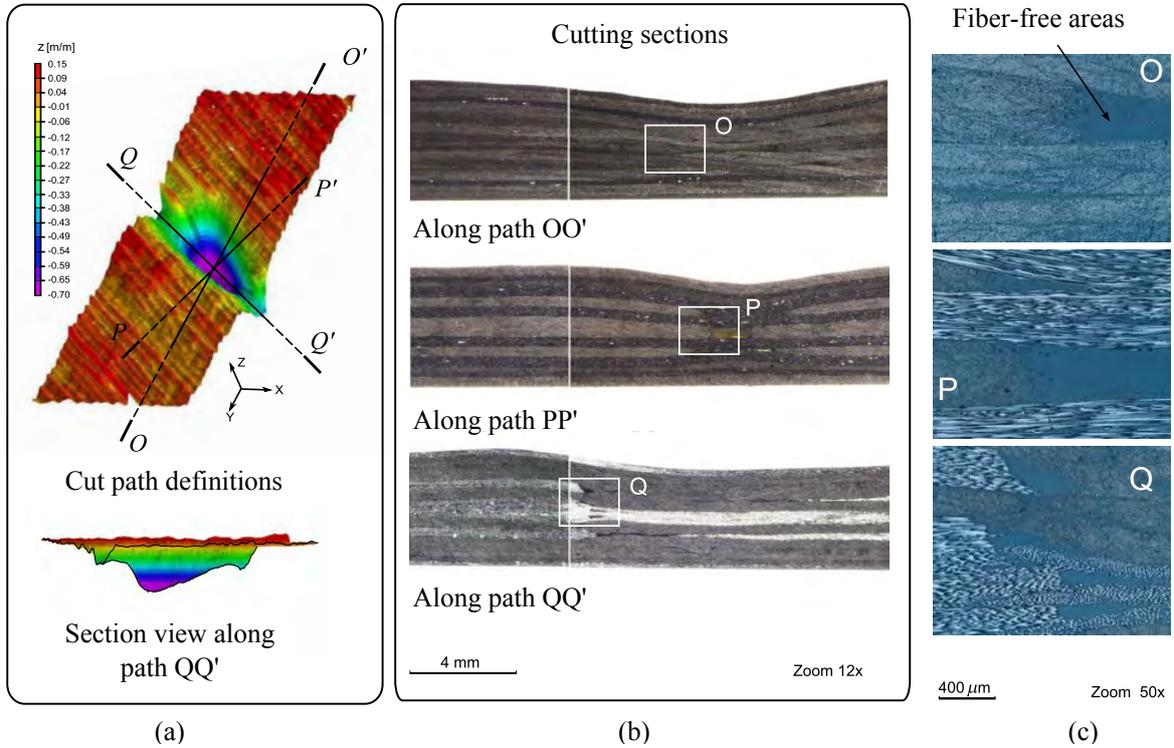
Figure 5: (a) Cut section definitions. (b) Different view for the configuration with tow-drop 0% coverage (magnification 12 \times). (c) Detailed gap micrography (magnification 50 \times).

In order to observe the extension of the rich-resin zones in the configuration with 0% gap coverage, three different sections have been analyzed along the specimen (see Fig. 5a). While it is true that, in the section QQ' , small dispersed gaps appear (see Fig. 5c, detail Q), in the sections OO' and PP' , all the gaps are clustered and concentrated. Here, the size of the gap defects is notable (see Fig. 5c, detail O and P), and the waving of the adjacent plies to fill the gap area is evident. The curvature of the plies is similar to the 100% gap coverage

case. Higher angle differences between adjacent layers reduce the waving of the tows.

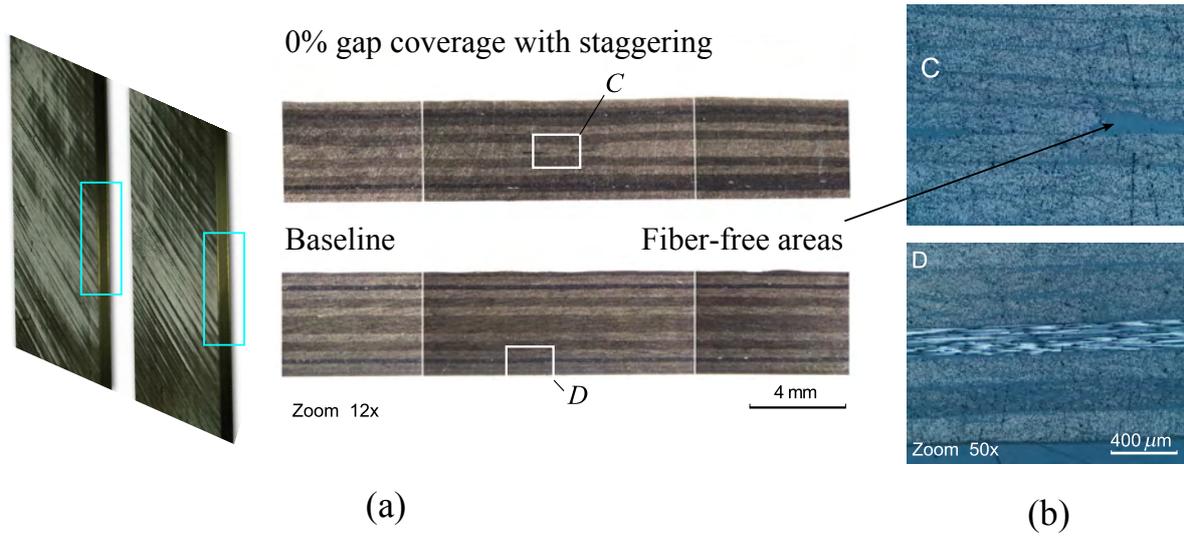
Figure 6: (a) Specimens. (b) Real tow-drop defect for the configuration with 0% coverage with staggering and the Baseline laminate (magnification 12 \times). (c) Detailed defect micrograph (magnification 50 \times).

If the staggering technique is applied to the 0% gap coverage case, the laminate thickness becomes more homogeneous because of the non-coincidence of gaps. A laminate surface similar to the baseline configuration is obtained, as confirmed by microscopic observation (see Fig. 6). Although clustering of defects is avoided, small resin zones still remain as the result of single gaps, as seen in the micrographic detail C in Fig. 6.

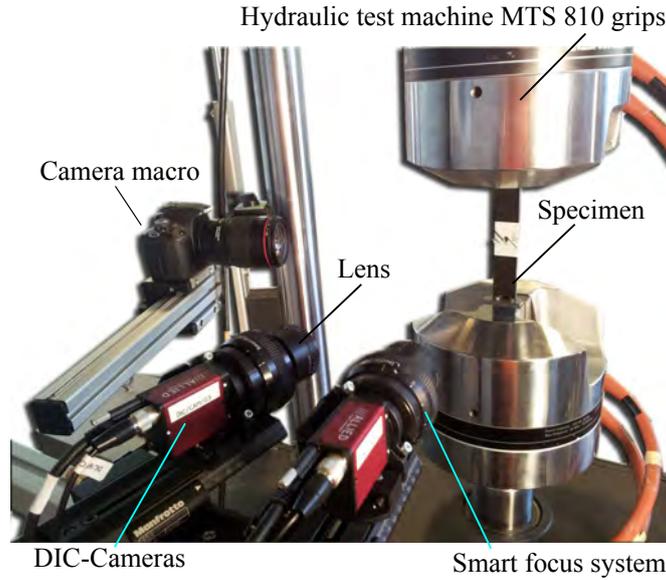
Figure 7: Open-hole tensile (OHT) specimen tensile test set-up with DIC technology included.

The VIC-3DTM Measurement System (Correlated Solutions, USA) was used in this test to measure the full-field displacements and strains on the outer 45 $^{\circ}$ ply with Digital Image Correlation (DIC). The DIC system set-up with a pair of stereo-mounted digital cameras is shown in Fig. 7. For real-time analog data acquisitions, the system is connected to the load output of the test frame controller, and records load and displacement data synchronously with the images.

The working distance of the DIC installation was set to 700 mm for the plain tensile test, whereas for the open-hole tensile it was set to 400 mm, for an object facet size of 90 \times 32 mm² and 45 \times 32 mm², respectively. The area of interest was spray painted guaranteeing the quality of the speckle pattern. The selected subset size was 29 (29 \times 29 pixel²) with a

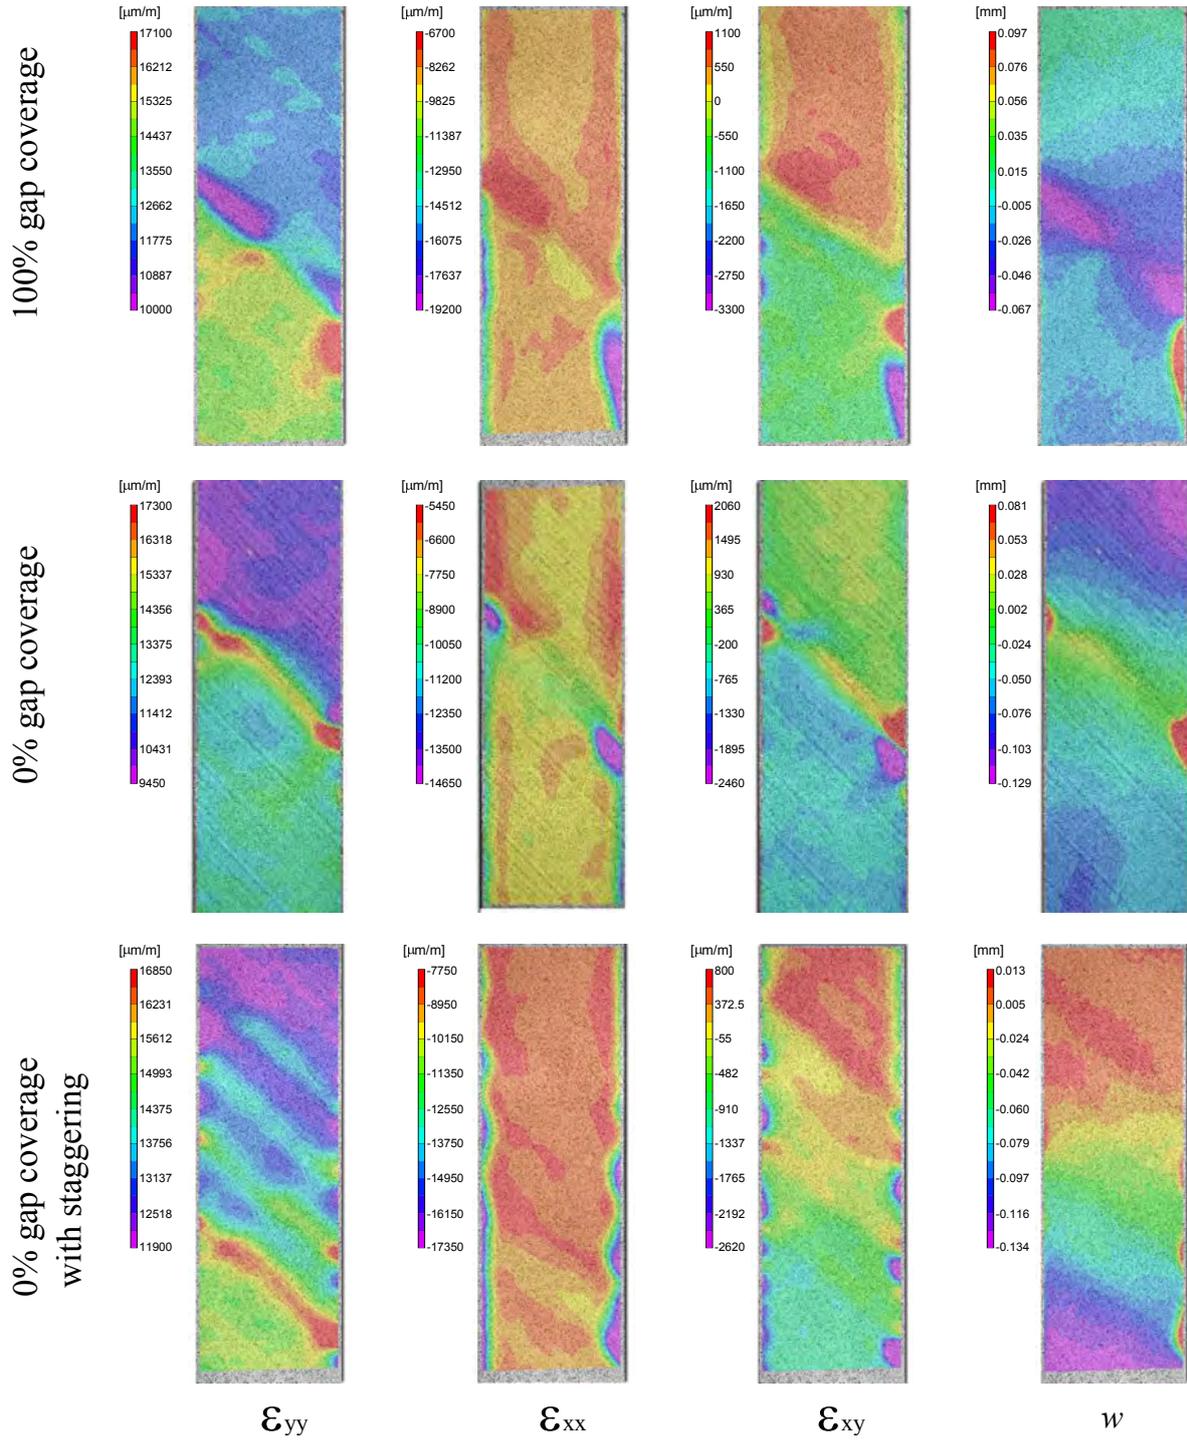
Figure 8: Strain field (ϵ) and out-of-plane displacement (w) comparison for un-notched tensile specimens on the outer layer at 45° just before final failure.

The first analyses were carried out by DIC at the moment just before the final failure of the specimens, in order to observe the influence of tow-drop defects on the strain field and on the out-of-plane displacement. Three specimens with tow-drop defects were selected, one for each configuration, and their behavior was compared. The longitudinal strain (ε_{yy}), transverse strain (ε_{xx}), shear strain (ε_{xy}) of the outer layer at 45° and displacement along the out-of-plane direction (w) throughout the survey area in question are shown in Fig. 8. In all cases analyzed, the load direction and the fiber direction at 0° corresponds to the vertical axis (y-direction). The fibers oriented at 51° are located below the defect zone. The strain variation due to the fiber angle discontinuity of ($51^\circ|39^\circ$) can easily be seen in the DIC representations. The strains concentrate in the vicinity of the defect areas which are critical zones for damage. On the one hand, in the case of 100% gap coverage, the longitudinal strains in the tow-drop area are lower than average strains resulting in overlapping and stiffer zones. On the other hand, in the configurations with 0% gap coverage, the defects result in material zones with lower stiffness and higher strain.

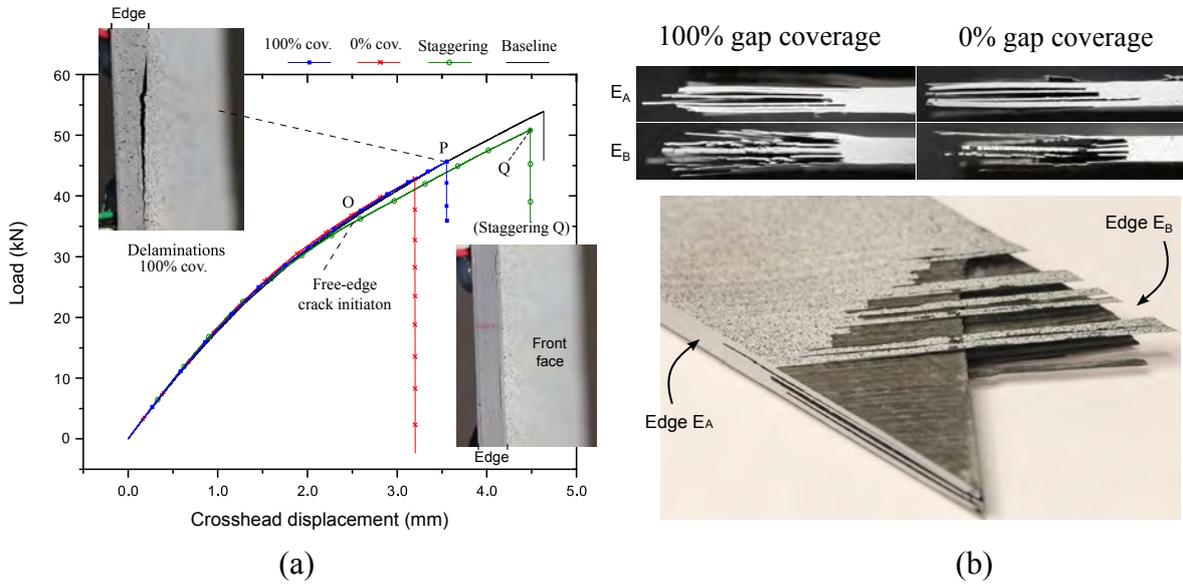
Figure 9: a) Comparison of load-crosshead displacement for different un-notched laminate configurations. (b) Delamination on tested specimen.

The analysis of the displacement (w) reveals delaminations near the edges of the specimens. In the non-staggered configurations, these delaminations are concentrated in the clustered regions of ply discontinuities. However, in the staggered specimens, the delaminations are less evident and distributed along the edge in different zones (see Fig. 9a).

For comparison purposes, the load-displacement curves for one specimen of each configuration are plotted in Fig. 9. The extensive non-linearity of the load-displacement curves prior to failure confirms a progressive loss of stiffness; probably as a result of both the appearance of matrix cracking in the off-axis layers, and the onset of delaminations across the tow-drop defect zones. Specimen collapse is caused by extensive fiber breakage.

In both of the non-staggered configurations, the edge photographs taken during the test reveal large free-edge delaminations in the zones with defects (Fig. 9a). For example, point O in Fig. 9a identifies the observable delamination onset on the free-edge for the configuration with 100% gap coverage, which advances up to point P where the specimen finally fails. This cracked zone coincides with the defect area. In such areas, the fiber angle discontinuities and the thickness variations increase the interlaminar stresses, which cause delaminations

in the free edges. Such stresses contribute to the weakening of the specimens. Hence, the failure of the plain tensile specimens begins at the edge and propagates along the defect. The staggered laminate configuration presents a structural behavior analogous to the baseline. Both lay-ups present similar observed free-edge delaminations. The crack delaminations are small and uniformly distributed across the edge of the laminate in comparison with the non-staggered configurations. In Fig. 9a, this failure mode is shown in the image taken just before final failure (point Q).

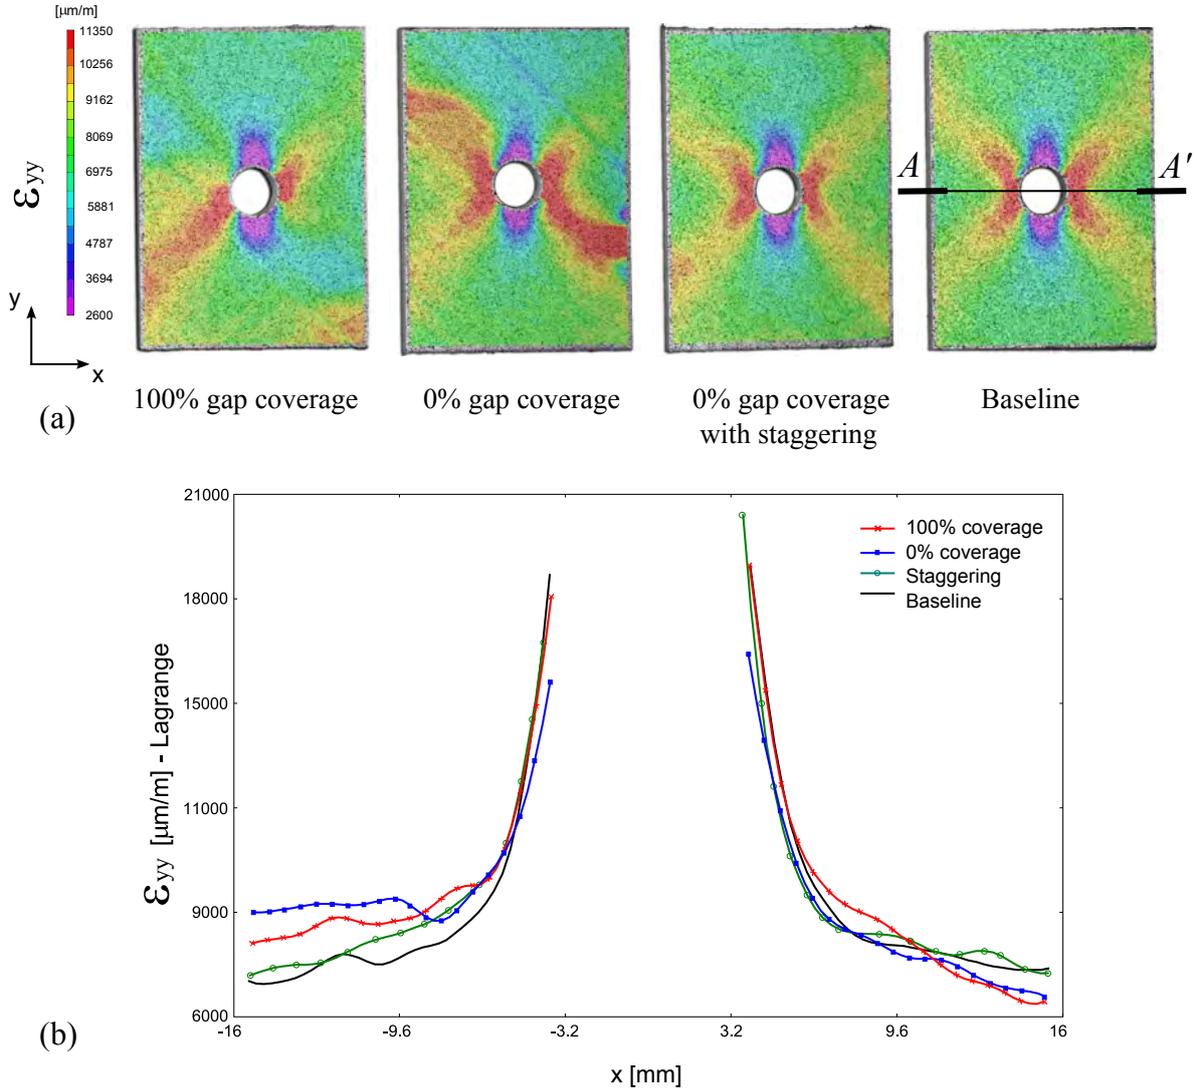
Figure 10: a) Longitudinal strain field for the outer layer of different OHT configurations just before visible crack initiation. b) Plot of the longitudinal strain ϵ_{yy} along path AA'.

In order to illustrate the longitudinal strain distribution (ε_{yy}), one DIC representation for each configuration has been selected and shown in Fig. 10a. The images depict the critical strain zone just before the crack initiation at the 45° ply; akin to where the onset of damage and the first evident delaminations are observed. When the 100% gap coverage is compared to that of the 0% gap coverage, the first reveals lower strains in the defect direction because of stiff zones caused by the ply overlapping, while in gap zones the strains were higher. For the staggered and baseline configurations, the strain fields are nearly identical. The variations of longitudinal strain (ε_{yy}) along path AA' (see Fig. 10a, baseline) in y-direction for the OHT configurations are plotted in Fig. 10b. As observed, maximum deformation is governed by the increasing stress values in the adjacent zones to the hole where the damage appears, and the manufacturing-induced defects have little relevance in the final failure process.

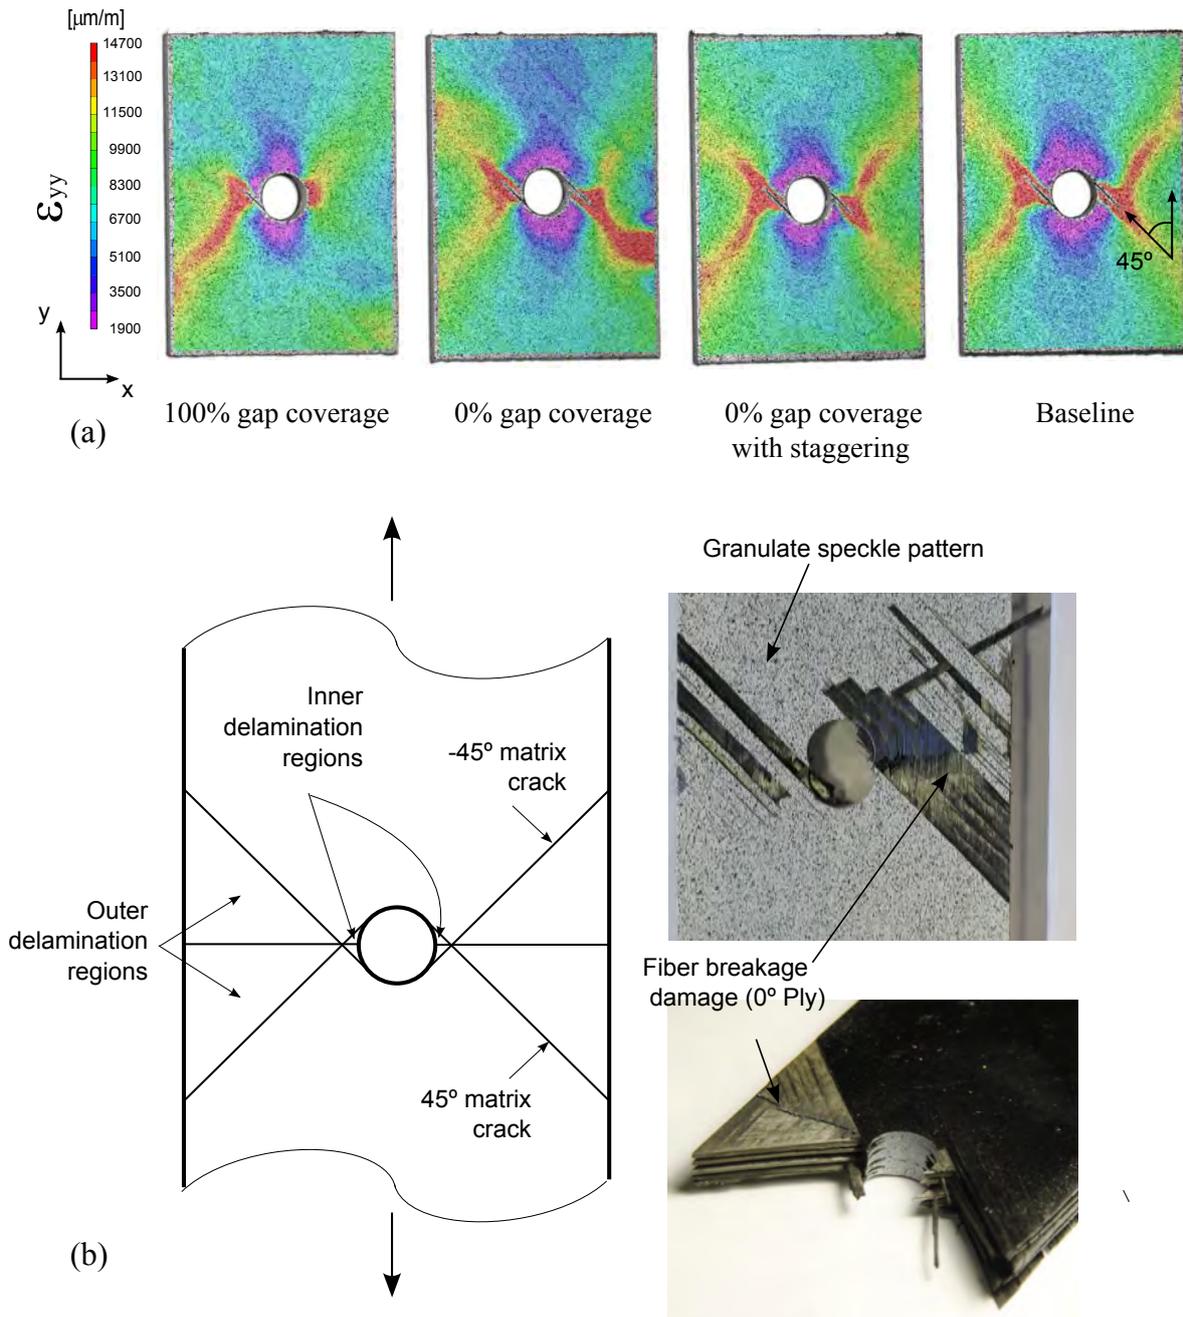
Figure 11: a) Longitudinal strain field for the outer layer of different OHT configurations just before final failure. b) Damage zones associated with the specimens.

The longitudinal strain field ε_{yy} for the outer layers at 45° of one test specimen, just before the final catastrophic failure, for each of the configurations tested are shown in Fig. 11. Here, the 45° matrix crack is clearly visible from the hole in the outer ply surface. This external damage is propagated asymmetrically across the width of the specimen to the specimen edges.

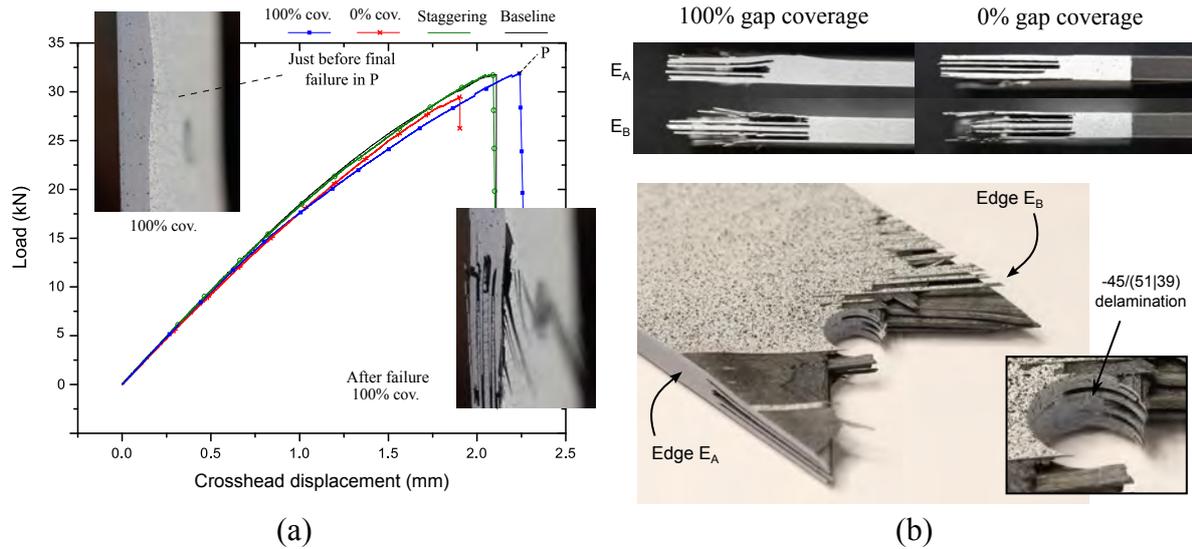
Figure 12: a) Comparison of load-crosshead displacement for different open-hole laminate configurations. (b) Delamination and damage on tested specimen.

The damage mechanisms for the OHT specimen observed in this experiment were similar to those observed by other authors for OHT specimens [34, 35]. Initially, isolated matrix cracking, splitting and delaminations at the hole edge appear (see Fig. 12b). Then, damage propagates across the width of the specimen, leading to final collapse. Fiber breakage in the 0° plies can only be observed after the final catastrophic failure. The failure mechanisms are represented in schematic form in Fig. 11b. Delaminations are controlled by the interlaminar shear stresses, increased by the free edge effect of the hole and the influence of the manu-

The OHT test load-displacement curves for representative specimens are plotted in Fig. 12a. The results show the similarity between the staggered laminate specimens and the conventional specimens. The load-displacement curves present less non-linearity than those of the un-notched specimens. In these specimens, the structural collapse was also controlled by a pull-out failure mechanism accompanied by delaminations. The post-fracture

the fiber orientation of 45° . Similar sub-critical damage mechanisms were observed for all specimens, as shown in Fig. 12b. The zoom on the open-hole region reveals how the damage is initiated in the form of isolated matrix cracks and delamination at the hole edge. This damage is mainly at the interface of the plies with overlap or gaps and conventional plies without fiber angle discontinuities.
